# Stress Corrosion Cracking Issues in Syngas Plants that may be Missed by Risk-Based Assessment\*

\*Published by the AIChE Annual Safety in Ammonia Plants and Related Facilities Conference 2014

**D. M. Firth, Metallurgist and C. W. Thomas, Metallurgist**  
Quest Integrity Group New Zealand

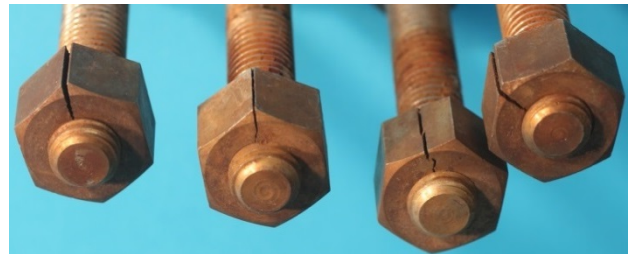
Cracking was observed in 303 stainless steel M18 grade 8F nuts on an 8 inch crude methanol bonnet valve flange that was mounted horizontally (studs vertical), see Figure 1. The methanol is normally at 30°C and the flange and bolts would be cooler. Each of the flange studs had two nuts and the central section of the studs were open to the atmosphere as the bolting was outside the gasket ring i.e. this was not a full face gasket. Only the lower nuts were seen to crack. The nuts may have been installed in the 1980's. Cracking commonly occurred through the apex of the hexagonal heads and not in the thinnest wall section.

*Figure 1. Cracked M18 grade 8F nuts from bottom of a bonnet valve flange*

Examination of nuts in similar locations in the Methanex New Zealand plants revealed that this problem was not isolated, nor confined to a single valve manufacturer, and a plant wide inspection program was instigated.

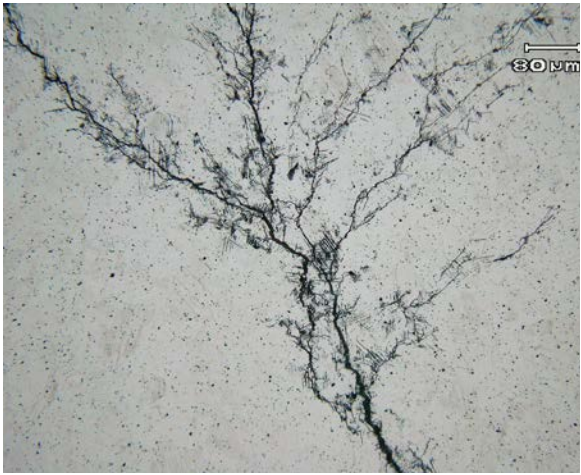
Examination of the failures revealed that the cracking was classic chloride SCC, see Figure 2. However, the initiation and propagation of the cracking was exacerbated by the following:

*Figure 2. Classic chloride SCC in the nuts*

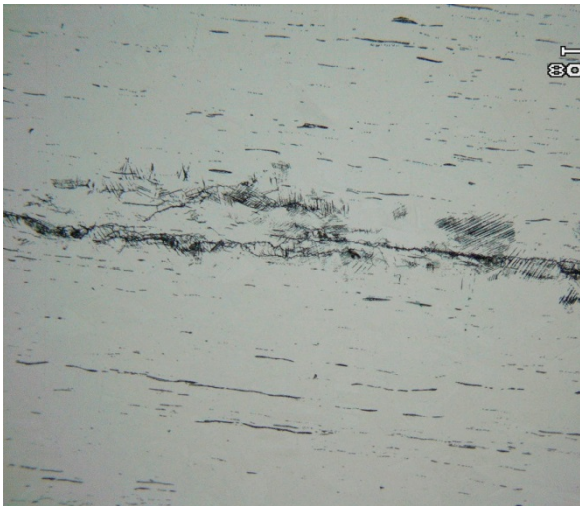
- Use of free machining steel, see Figure 3, as the SCC/corrosion initiated and propagated along inclusions.
- Corrosion in the nuts installed under the flanges, see Figure 4. Rain water/wind blow salt had been filling the lower bolt holes and chloride concentration occurred. The corrosion present caused an increase in the hoop stress in the nuts as a result of the

*Figure 3. Cracking along non metallic inclusions*

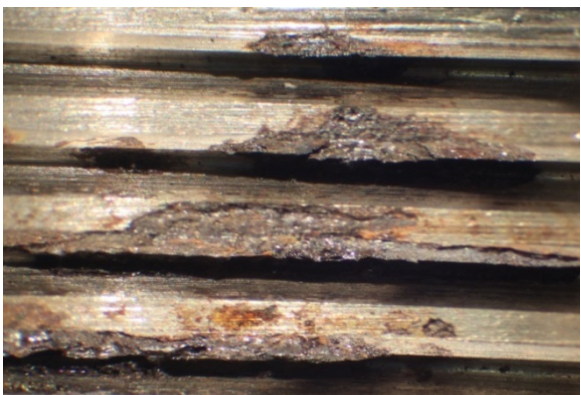
formation of corrosion product and oxide jacking.

*Figure 4. Corrosion in the nuts*

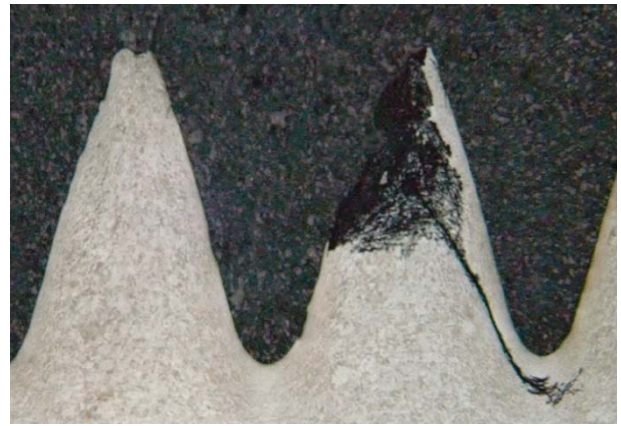
Corrosion and localised SCC had occurred on the B8 (304) stainless steel studs, see Figure 5. However this damage was confined to the region of the threads.

*Figure 5. Corrosion and SCC of the rolled threads in the B8 stainless steel stud- pitch of 2.5mm*

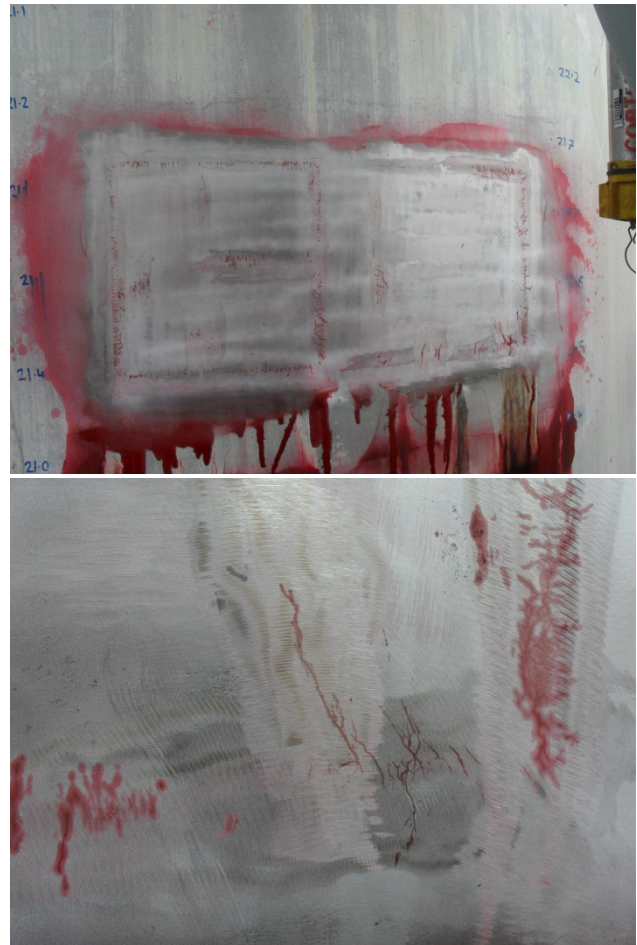
Severe stress corrosion cracking was observed in the CSBP Ltd, Western Australia 304L unlagged stainless steel absorber column of a nitric acid plant after 15 years of plant operation. The temperature of the column in the region of the cracking is approximately  $70^{\circ}\text{C}$  ( $158^{\circ}\text{F}$ ). The cracking was found when rust staining/leaks were observed. A redundant support plate, initially installed for site fabrication, was removed to allow for inspection to determine the cause of the leaking. Branched chloride SCC was present in the vessel wall next to welds behind the support plates. The chloride concentration had built up over time in the space between the support plate and shell. This build up had occurred by rain water entering through open tell-tale holes and then evaporation. The chloride was present in the atmosphere as the plant is located very close to the sea and also adjacent to other industry.

Figure 6. SCC under support plate at CSBP.

Assessment of the extent of the SCC showed it was confined to the support plates and as result did not affect the fitness for service of the vessel. The initial cracking damage was cut out and a patch repair was successfully carried out. For other support plates on the vessel and on other stainless steel vessels, redundant plates were removed and for the others on high risk vessels the tell-tale weep holes were sealed with silicon to prevent water ingress. For lower risk vessels where minor leaks can be tolerated the

support plates are visually inspected for signs of leaks.

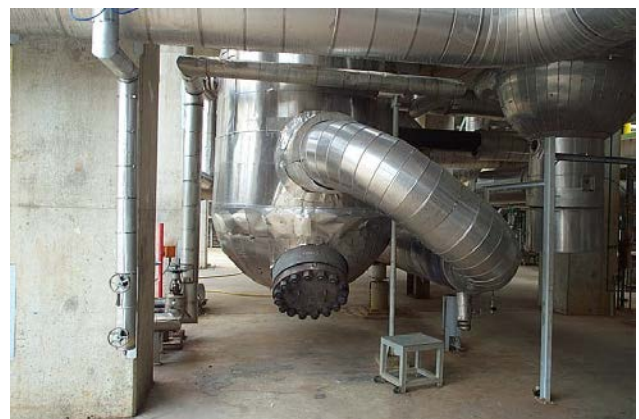
Kaltim Pasifik Amoniak (KPA) 2000 MTD ammonia plant was commissioned in 2000. It has a vertical U tube steam superheater (steam on the shell side) in the synthesis loop between two ammonia converters, see Figure 7. In September 2003 an excessively high pressure drop developed across the second converter and the plant was forced to shut down [4]. Some of the stainless steel scalloped inlet tubes around the catalyst bed and the inner exit tube had deformed. Catalyst had moved and blocked the inlet. The superheater was pressure tested and 60 tube-to-tube sheet Inconel 182 weld joints were leaking, see Figure 8 and were subsequently repaired [4]. It was shown that steam had entered the process side during start up and shutdown when the steam pressure was higher than the loop pressure and condensed. Condensed water formed in the channel section which then dissolved carry over iron catalyst dust. During start up approximately 1m<sup>3</sup> of water was blown into the converter. This flashed to steam and the fine holes in the inlet scallop tubing were blocked with the iron precipitates formed from the dissolved catalyst dust. The

vessel had also suffered severe cracking at the channel closing weld and as a result was regularly inspected and repaired [5]. Additional leaking/cracked tube to tube sheet welds were found in 2004 and samples were taken to investigate the cause of cracking. The relevant data for the superheater are given in Table 2.

*Figure 7. Channel section of superheater at KPA.*

The superheaters in the KPA and sister plant were both eventually replaced with 347 stainless steel tube to tube sheet welds with a J preparation to allow a double weld pass combined with physical and operational modifications to ensure condensed water cannot form on the tube sheet and that there is virtually no chance of chloride concentration.

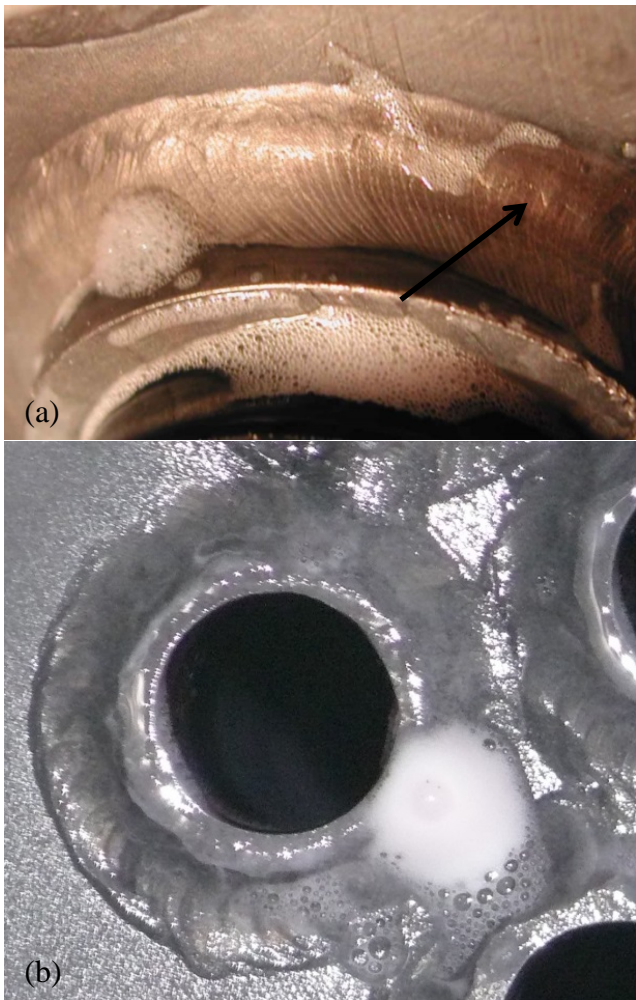
service the Inconel 82 tube to tube welds were inspected by dye penetrant testing and were found to be free of cracks. However, nine welds were found to be leaking, see Figure 8.

The cracking seen at KPA initiated at the base of the crevice between the tube sheet and the tube OD and propagated primarily transgranularly relatively straight across the thinnest throat section of the weld and primarily driven by the stress, see Figure 8. No obvious contamination such as chlorides or caustic was identified that could cause SCC. However, especially where a leak had occurred, the base of the crevice between the tube and tubesheet and the crack was filled with deposits that were analysed and found to be rich in iron with a low chromium content. This indicates that the hydraulic tube expansion could not be relied on to produce a pressure seal.

Figure 8. Leak test on tube to tube sheet weld. Showing the location of the fine cracking present in the KPA superheater (a) and a leak in the CSBP pre-superheater (b)

- The best method to locate the PWSCC in tube to tube sheet welds is specialised UT from the bore of the tube as this will detect cracking prior to leakage. Helium leak testing is far more reliable than dye penetrant testing and air leak testing to locate through wall cracks in tube to tube sheet welds.

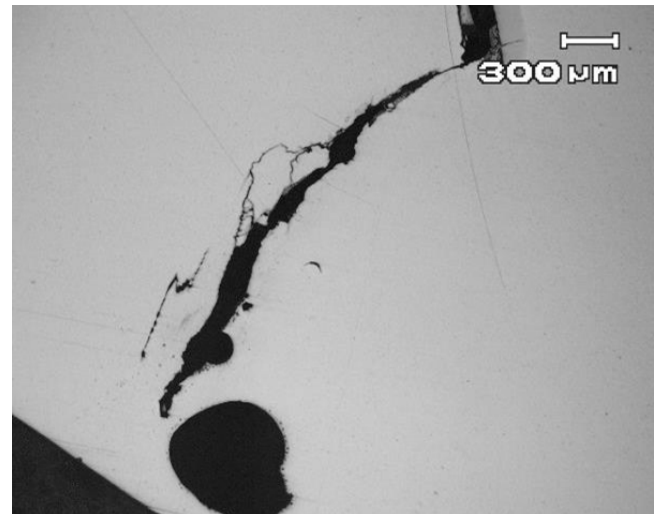
Figure 9. Cracking in Alloy 182 tube to tube sheet weld

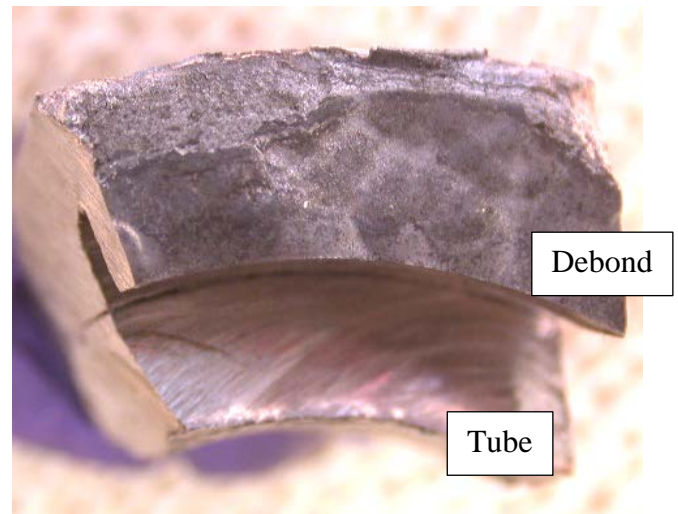
Figure 10. Debond in the sample taken from the weld in Figure 8

In addition to the tube to tubesheet cracking, cracking was also detected on the bond line of the Inconel 182 weld overlay and the F22 tube sheet in the region adjacent to the tubes, see Figure 10. This cracking could be either or both PWSCC and hydrogen cracking along the hard brittle layer at the weld /substrate interface.

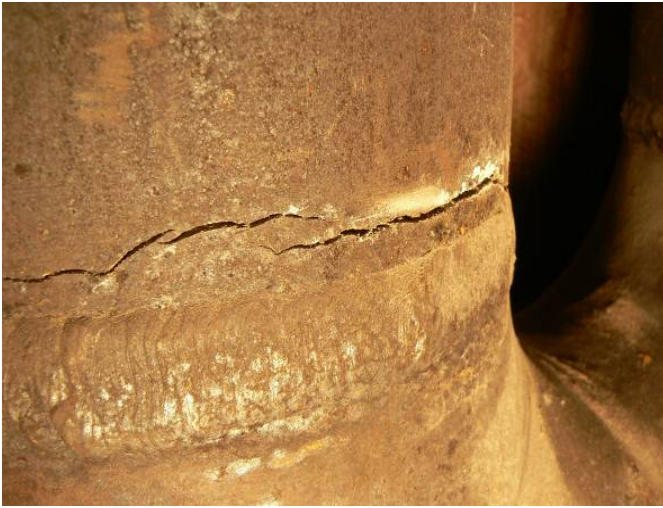
desulphurisers and as a result the trim heater is only normally used to raise the gas temperature by a small amount. However, at the beginning of start up the gas is heated from ambient. The gas enters the trim heater and is split into four coils that go through the furnace. Each coil has a low alloy steel finned convection section and then six vertical 6 inch (152mm) schedule 40 304H stainless steel tubes mounted around a quadrant of the wall of the circular furnace with forged return bends welded at either end. The maximum design tube metal temperature in the 304H tubes was 479°C (894°F). The exit is at the top of the furnace through a penetration in the furnace roof. The cracking was located next to the bottom bends of the last tubes prior to the exit of each of the four coils.

Figure 14. Cracking of the outlet 304 stainless steel tubes in the trim heater

So that the plant restart was not delayed, the trim heater radiant section was rapidly retubed with carbon steel tubes and the operating temperature has been reduced. These have operated successfully since that time without any significant damage to the tubes [10].

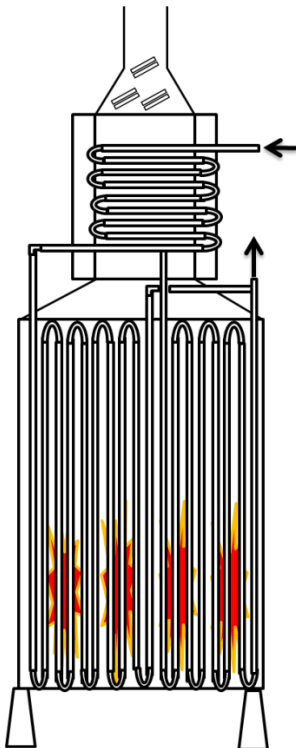
The trim heater is a circular bottom gas fired furnace used in normal service to heat natural gas from 347°C to 400°C (657°F to 752°F), see Figure 15. The inlet gas is heated in an exchanger from the effluent of the

Figure 15. Schematic drawing of the cylindrical trim heater. Showing two of the four coils  
Cracking occurred in each outlet tube next to the bottom bend

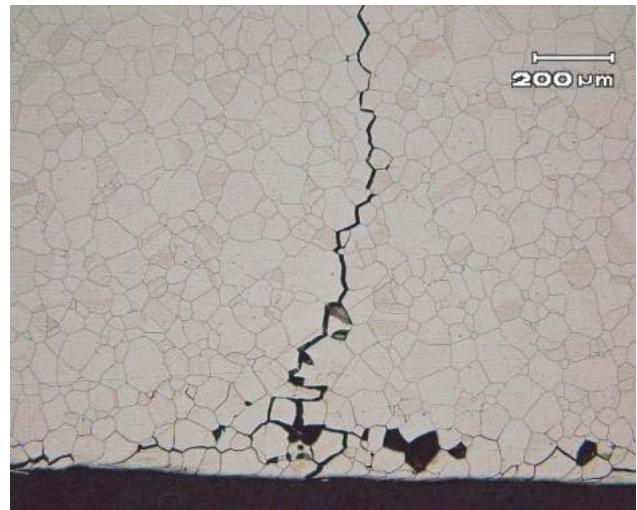
The cracking was classic intergranular SCC with extensive grain boundary attack at the outer surface, see Figure 16, and very high levels of sulfur and chlorine were detected on the tube OD and fracture surface. In addition, the 304H tubes were sensitised, as expected, as a result of the operational conditions. Additional testing showed that the cracking damage was present away from the welds and trials to repair the furnace were unsuccessful. In addition, intergranular attack was also seen on the ID of exit tubes away from the main failures.

The presence of the surface intergranular attack and the cracking indicates that moisture had been present and as a result the cracking must have occurred during the shutdown. The bottom of the outlet tube where the cracking occurred is below the region where the burner exhaust gases would normally condense i.e. there was no reason why high levels of sulfur would form in the location even if the gas supply had high sulfur levels. In addition both plants have been restarted numerous times in the past without any issue. It was therefore concluded that a concentration process was present during the extended shutdown that effectively washed sulfur rich gas deposits off the tubes and concentrated it at the bottom of the tubes. Water could have ingressed through the seal around each exit tube at the top of the furnace and run down the tubes. The bottom of the tube was near to the open burner ports and as result this area would become wet and the concentration of sulphur and chloride salts was therefore possible. The PTASCC/chloride SCC then occurred at ambient temperature primarily driven by the residual stress adjacent to the weld region in the regions that were sensitised.

Figure 16. Intergranular PTASCC from the outside of the tube adjacent to a circumferential weld
