EVALUATING THE VARIABLES THAT IMPACT ULTRASONIC TESTING

A thesis presented to the Faculty of the Graduate School at the University
of Missouri – Columbia

JULY 2014

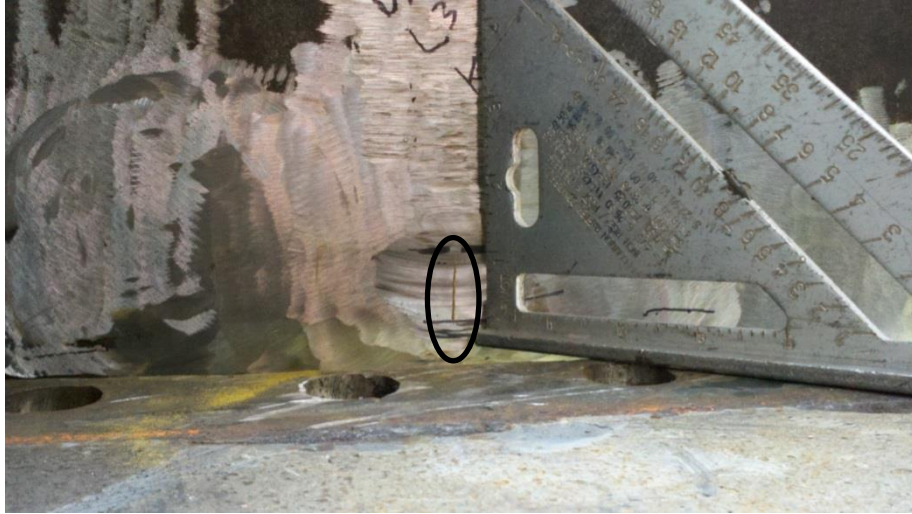
Figure 1-2: Vertical crack located in the SMB arch tie butt weld.

The SMB was evaluated using multiple NDT technologies, during the inspection, including: magnetic particle testing (MT), radiographic testing (RT) and UT (Hotaki and Washer 2014). The results from these inspections indicated discrepancies between the different NDE technologies. A single, highly reliable NDE technology would be preferred in bridge inspections rather than multiple conflicting technologies which yield conflicting test results.

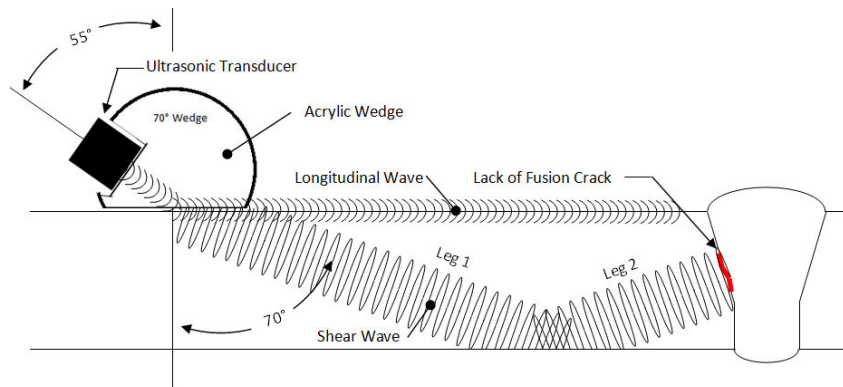
Figure 2-1: Wave path of a 70° angle beam wedge transducer

This research focuses on the pulse echo technique which requires a single probe that generates and receives the reflected wave (Firestone 1942, Desch, Sproule et al. 1946). Figure 2-1 illustrates the wave paths of the shear and longitudinal waves from a single ultrasonic transducer. The pulse echo technique is typically preferred for bridge inspection because it only requires access to a single weld side, unlike TOFD, which requires access to both sides.

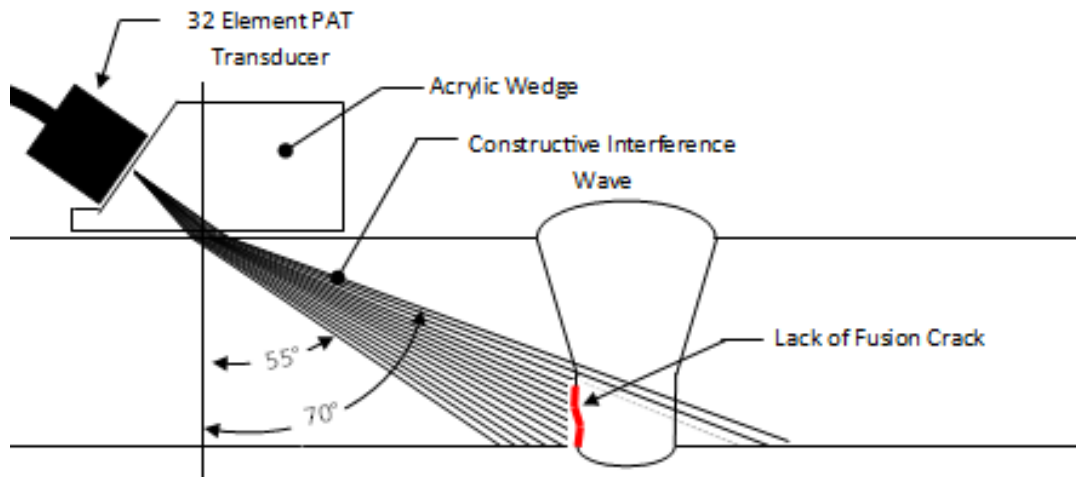
Figure 2-3: Shear wave path of a 32 element, PAUT transducer

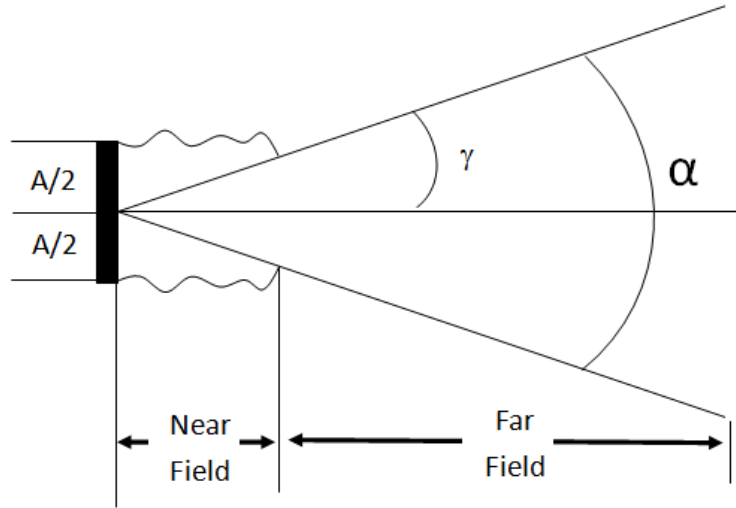
Figure 2-4: Sound field diagram

The term “sound field” refers to the behavior of ultrasonic waves as the waves propagate through the material prior to encountering any defects. Once the acoustic wave reflects off a defect and echoes back to the transducer, the wave behavior is known as the “echo field”. Figure 2-4 shows the two regions in each sound field: the near field and the far field. The near field is a region that contains interference due to the various wave pressures resulting from the initial pulse. These wave pressures propagate through the material based on the transducer’s oscillator geometry. The near field starts at the beginning of the sound field and ends at the last interference point. The far field region begins at the end of the near field region. This region is ideal for defect inspection because it does not contain any wave pressure interference.

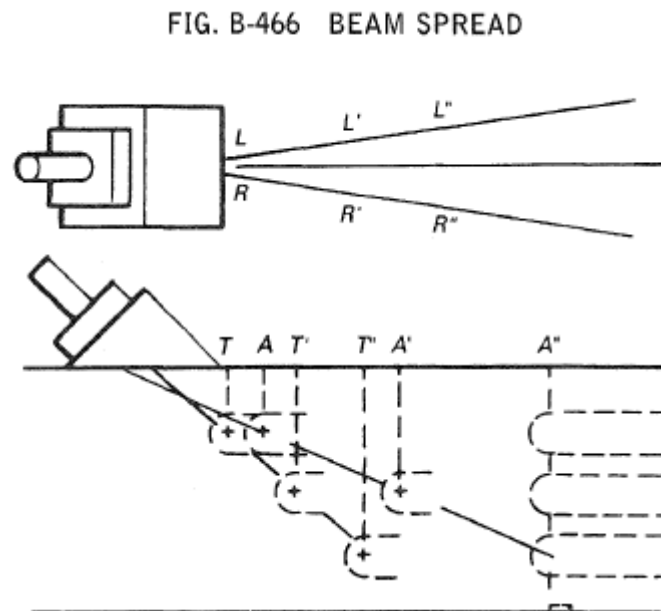
Figure 2-5: Beam spread calibration of the ASME Ultrasonic Code

The ASME ultrasonic testing code addresses the effects of beam spread in the automated probe qualification section. In order to ensure the entire weld volume is inspected, transducers must be spaced so that a minimum of 10% scanning overlap is attained. In order to determine the overlap from each transducer, a calibration block as seen in Figure 2-6 is used to determine the left/right and towards/away beam spread angles.

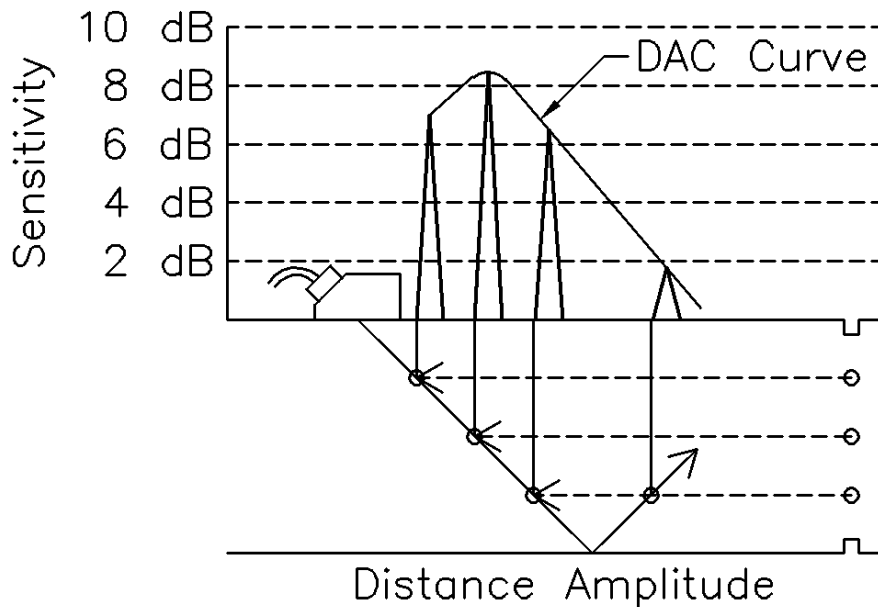
Figure 2-6: DAC curve construction

The ASME code uses a distance amplitude correction (DAC) curve to develop a reference level as seen in Figure 2-6. The DAC curve is developed using the maximum reflected amplitude from side drilled holes of similar diameter at different depths. The indications are of similar sized holes; however, the reflected amplitude decreases due to the material attenuation. These indications are used to develop a reference line used to determine a defect's acceptance or rejection. If any measured indication is larger than the DAC curve, the indication represents a defect larger than the side drilled hole at that depth. Any defect that is 20% of the DAC curve is further characterized and compared to the acceptance criteria. During the initial inspection, the ASME code requires that the sensitivity level is set 6 dB or higher than the reference level to ensure all possible defects are detected. These indications are then further evaluated to establish their severity.

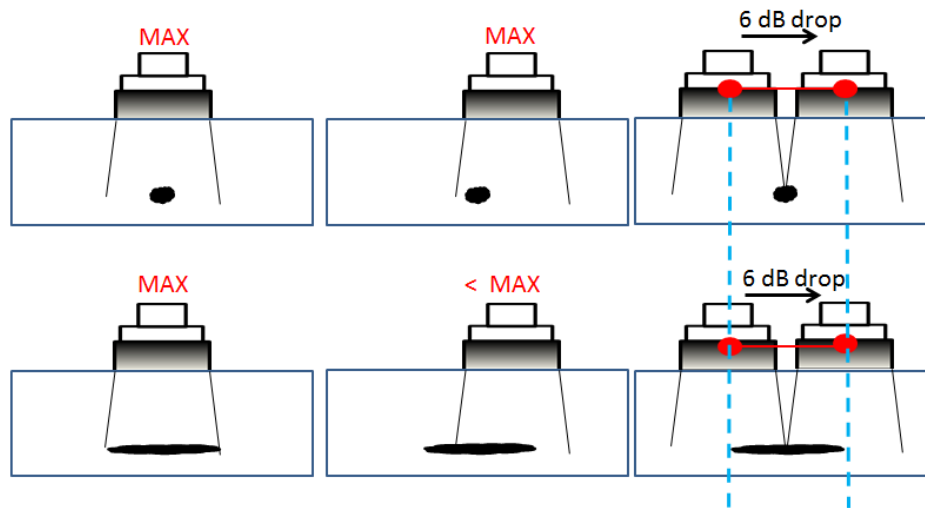
Figure 3-1: Diagram showing the overestimated length measurement of a small defect

The results from the Sherman-Minton Bridge performance evaluation found that when the defect length is smaller than the size of the transducer, the measured length is much longer than the actual defect length. When the transducer scans a defect smaller than the transducer, the entire defect is encompassed in the transducer scan as seen in Figure 3-1. The defect is completely encompassed in the scan, resulting in an extension of length at which maximum amplitude is attained. During inspection, the reflected amplitude is averaged over the area of the oscillator, if the defect is encompassed by the transducer over a length of 0.1", then the measured length may increase by 0.1".

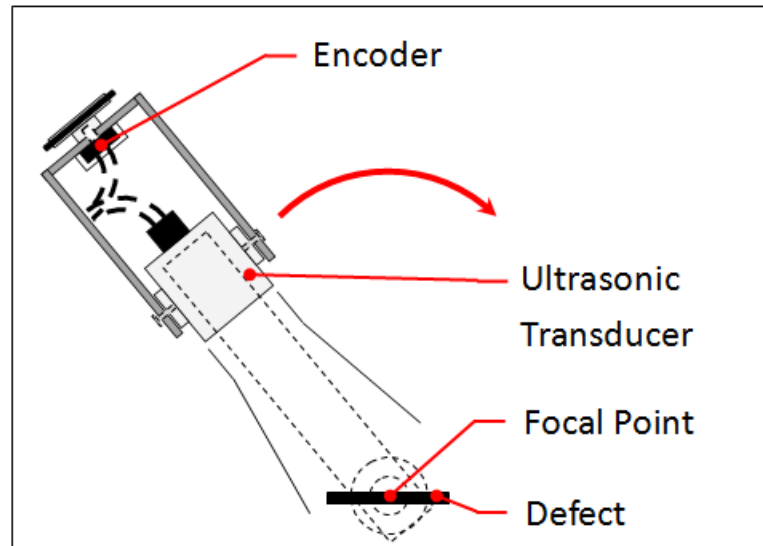
Figure 3-2: Defect Angle test setup

This test evaluates three slots from the LA1 plate to determine the effect the defect angle has on different sized defects. As discussed in Section 2.3.1, the reflected amplitude decreases depending on the defect angle and the defect size. The 3/8", 3/4" and 1.5" slots in the LA1 test specimen were inspected. These slots were inspected to determine the decrease in reflected amplitude as the transducer rotates about the defect for defects both larger and smaller than the transducer.

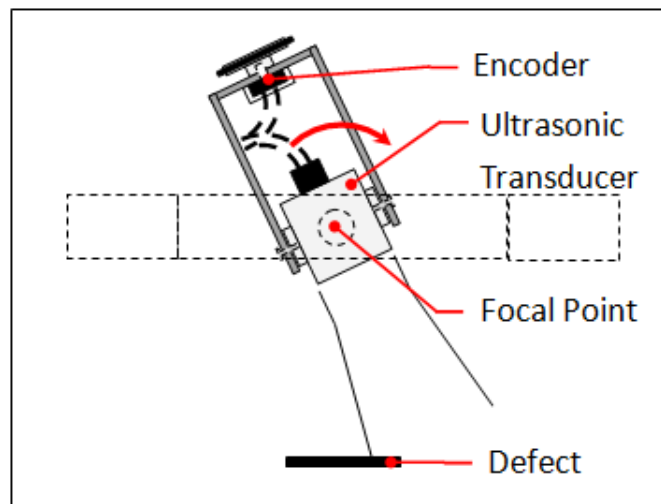
Figure 3-3: Transducer rotation test setup

This test evaluated defect both larger and smaller than the transducer. The 1/4" and 1/8" flat-bottom holes in the FBH1 plate and the 3/8", 3/4" and 2.25" slots from the LA1 plate were inspected to determine the effect of transducer rotation on different sized defects. The flat bottom holes in the SDH1 and the bottom corners of each LA1 slot were inspected.

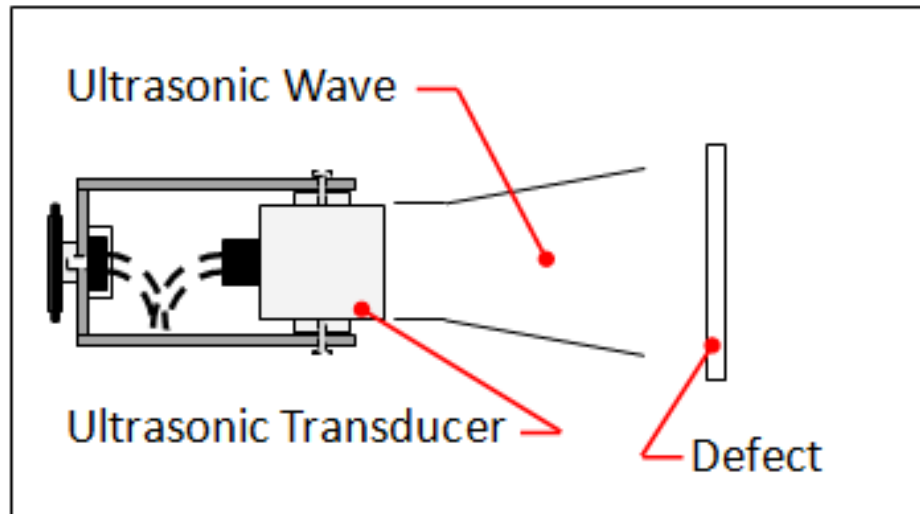
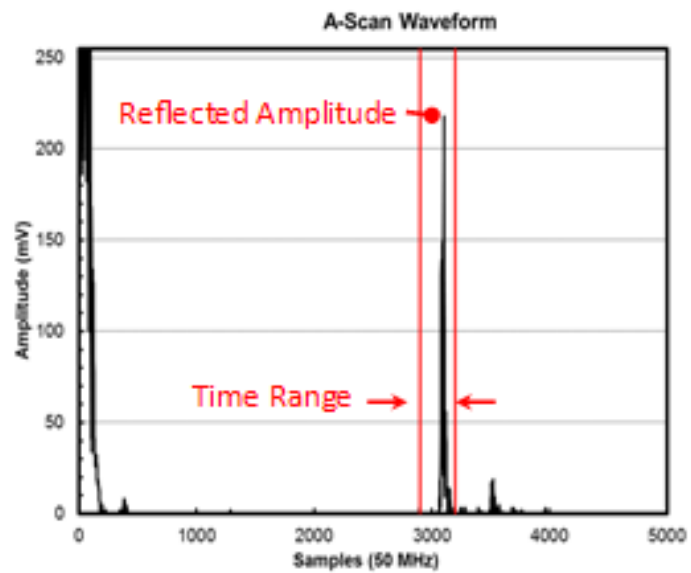
Figure 3-4: A-Scan waveform example indicating the B-Scan time range

Figure 3-4 and Figure 3-5 shows an example of both A-Scans and B-Scans of the same test. The two vertical lines in Figure 3-4 represent the time range calculated to analyze the defect indication. The maximum amplitude from each time segment is identified and associated to its location provided by the encoder. The B-Scan displays the maximum amplitudes found in the given time range versus the encoder locations as seen in Figure 3-5.

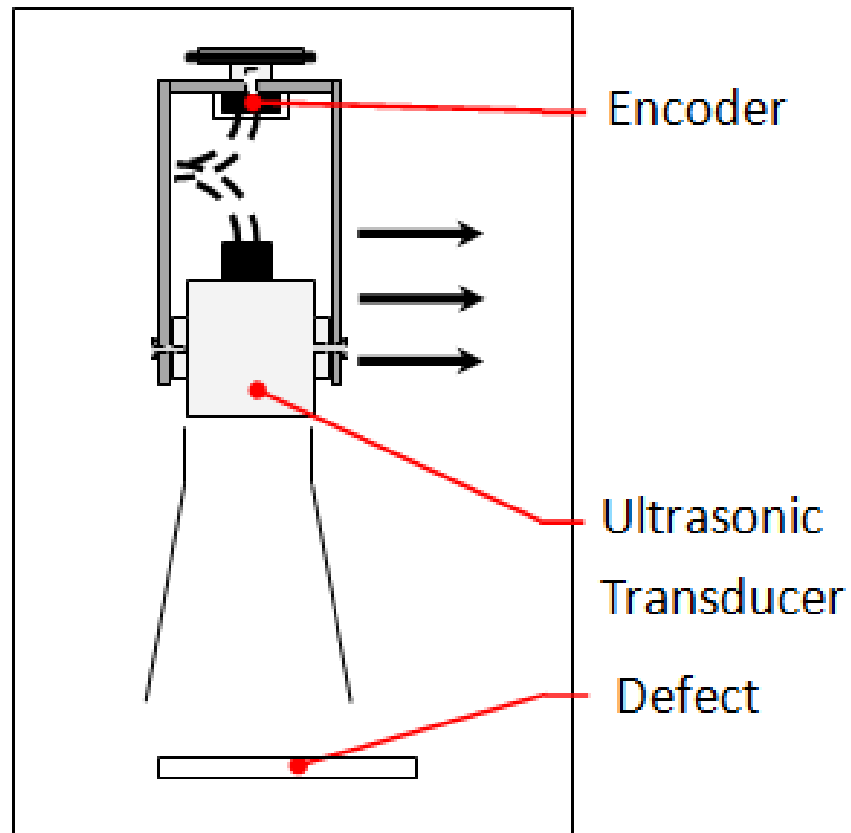
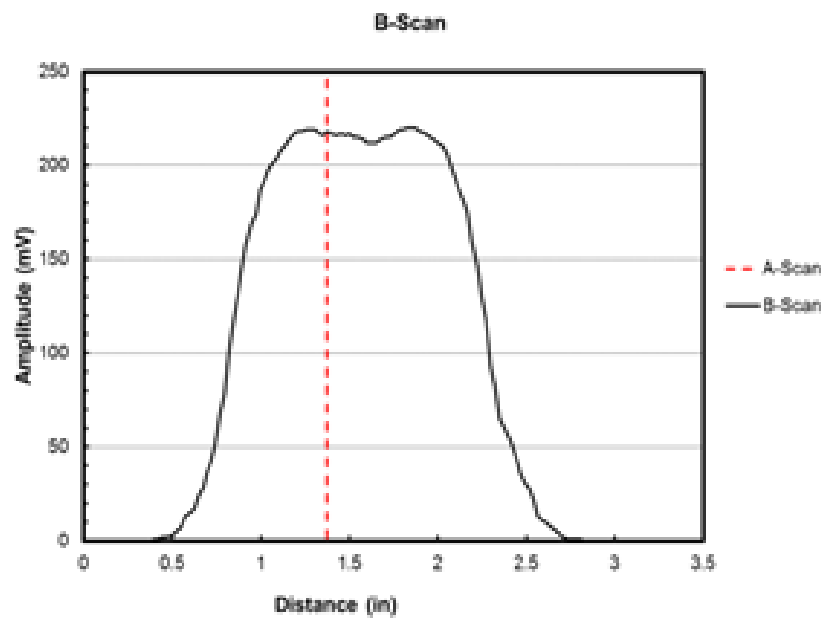
Figure 3-5: B-Scan showing location of the A-Scan measurement

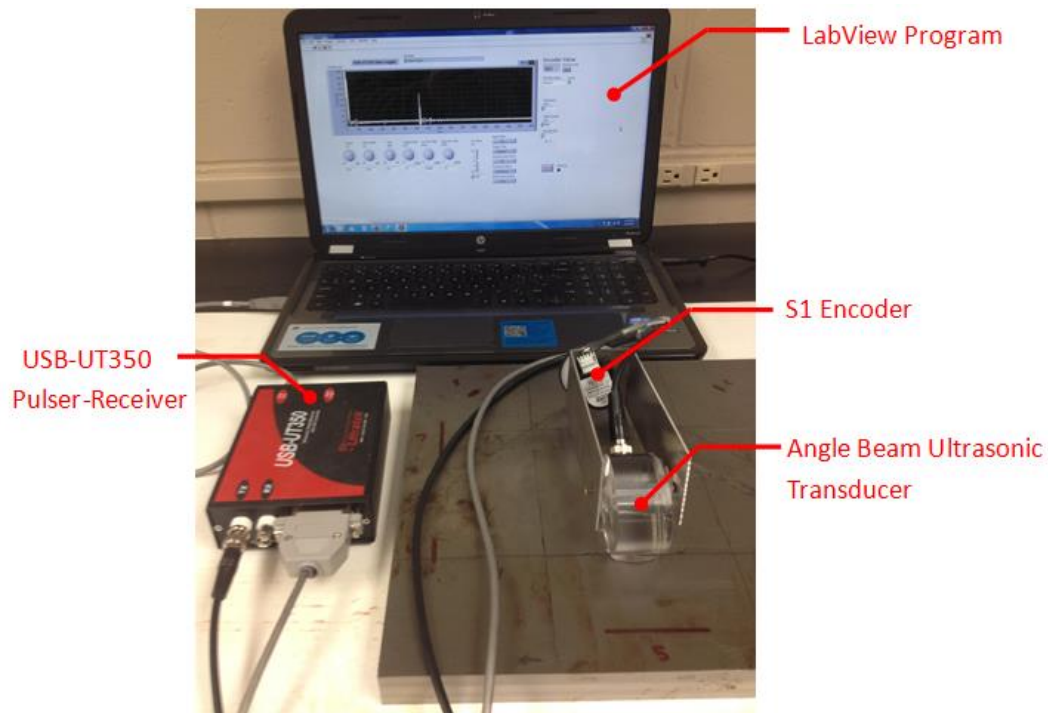
Figure 3-6: Experimental Setup

The experimental test apparatus used in each test procedure accomplished for this research is shown in Figure 3-6. The test apparatus consisted of an ultrasonic transducer, encoder and a pulser-receiver controlled by a LabView program on a laptop. The three AWS ultrasonic transducers with acrylic wedges were the 45°, 60° and 70° probes. The USB-UT350 pulser-receiver was chosen for its encoder capabilities. The S1 encoder was chosen for its size and axel location.

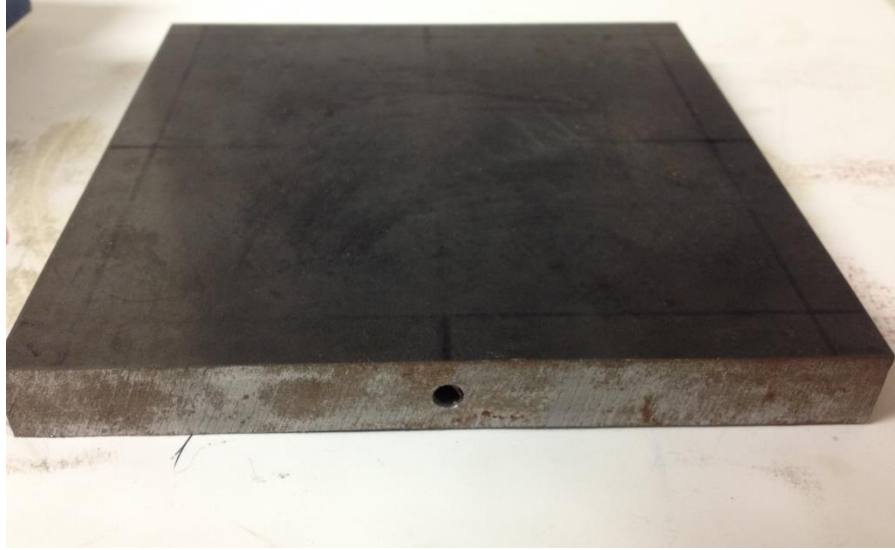
Figure 3-7: FBH1 Plate containing four 1/2" deep flat bottom holes

The FBH1 is a 7" x 7" x 3/4" square A36, steel plate containing four 1/2" deep holes of varying diameter shown in Figure 3-7. The plate has four side drilled holes drilled of 1/4", 1/8", 1/16", 1/32" diameters drilled 1/2" into the plate. The size of the 1/32" hole was on the limit of detection because it is close to half the wavelength of a 2.25 MHz transducer. The other defects have diameters 2, 4 and 8 times the size of the 1/32" hole. Schematics of the FBH1 plate shown in Figure 3-7 are located in Figure A-1.

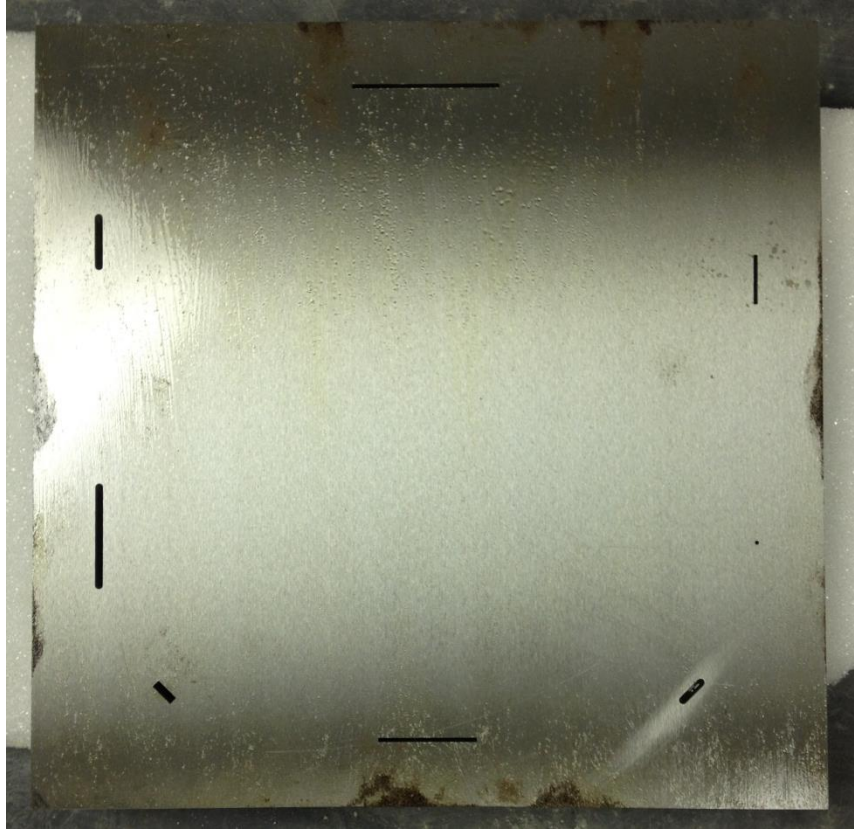
Figure 3-8: LA1 test specimen containing 8 defects with different geometries

The LA1 specimen is made of A36 steel, 1" thick 12"x12" with electric discharge machined (EDM) cuts. There are eight cuts of varying lengths, as seen in Figure 3-8. Four rectangular slots were cut through the steel at different lengths. Three fingernail-like grooves were made in the steel to resemble fatigue cracks. One 1/16" diameter hole, similar to the 1/16" diameter hole used for calibration, was cut into the plate. The defect lengths were designed so that some defect lengths were smaller than the transducer and some defect lengths were larger than the transducer. Schematics of the LA1 plate shown in Figure 3-8 are located in Figure A-3.

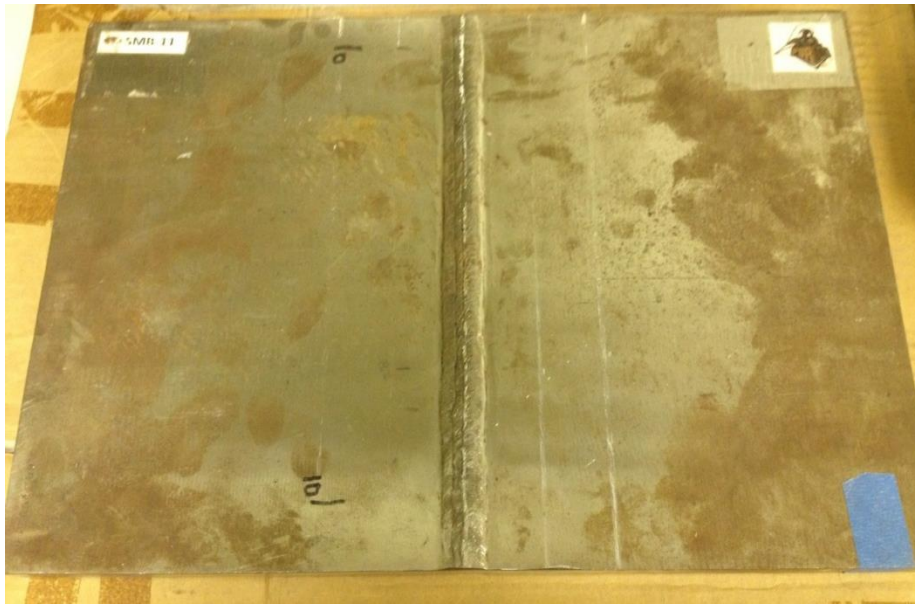
Figure 3-9: SMB-11 plate

welded plate, as seen in Figure 3-9 has three fabricated cracks implanted into the volume of the weld. These implanted defects provided a realistic sample of cracks in steel welds. Schematics of the SMB-11 plate shown in Figure 3-9 are located in Figure A-2.

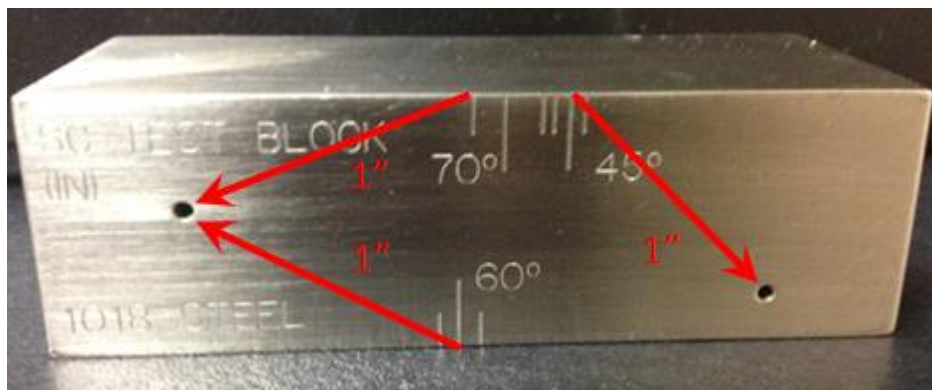
Figure 3-10: Sensitivity Calibration Block

The SC calibration block has two 1/16 in diameter holes located within the material as seen in Figure 3-10. The SC Block was designed so that the acoustic waves of each angled transducers travel 1” into the material to detect each hole from the designated positioning.

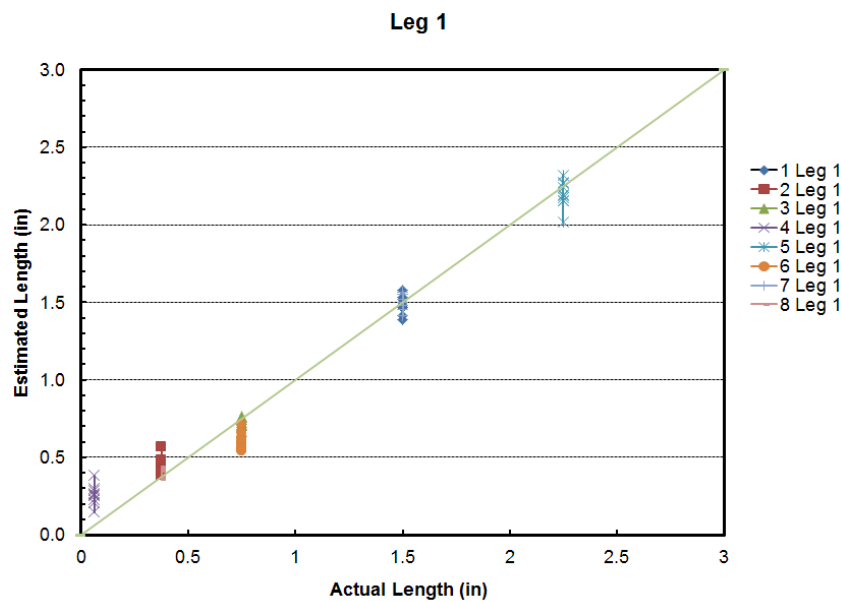
Figure 4-1: Length measurements vs actual length of all LA1 defects in Leg 1

Table 7 indicate that the length measurements are impacted by the defect length relative to the transducer length. Defects shorter than the 0.625" transducer length were affected by the beam spread and were initially oversized. Table 7 shows that the length measurements of the 1/16" and 3/8" slots increased from 0.257" to 0.286" and 0.391" to 0.5975", or 11% and 53%, respectively. Defects larger than the transducer length were measured near or shorter than the defect.

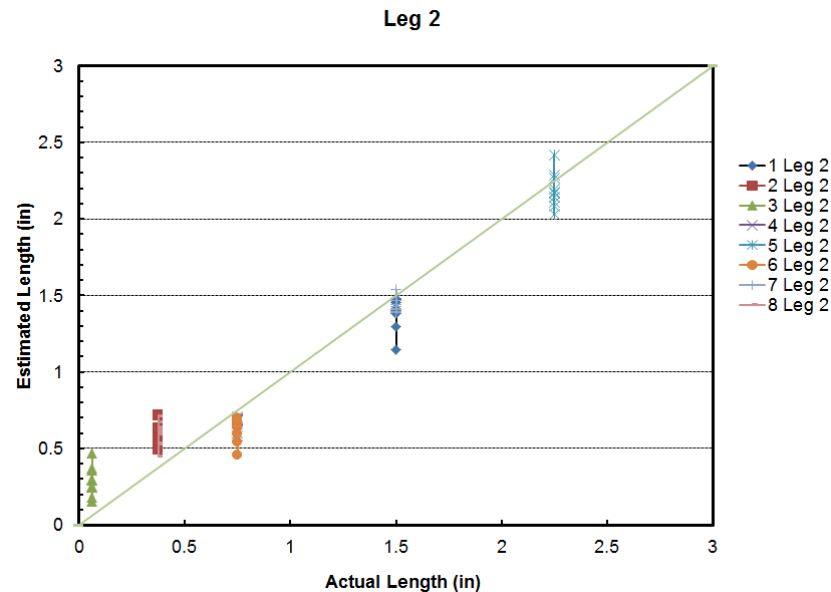
Figure 4-2: Length measurements vs actual length of all LA1 defects in Leg 2

same length. The loss in defect volume, caused the measured length to be undersized.

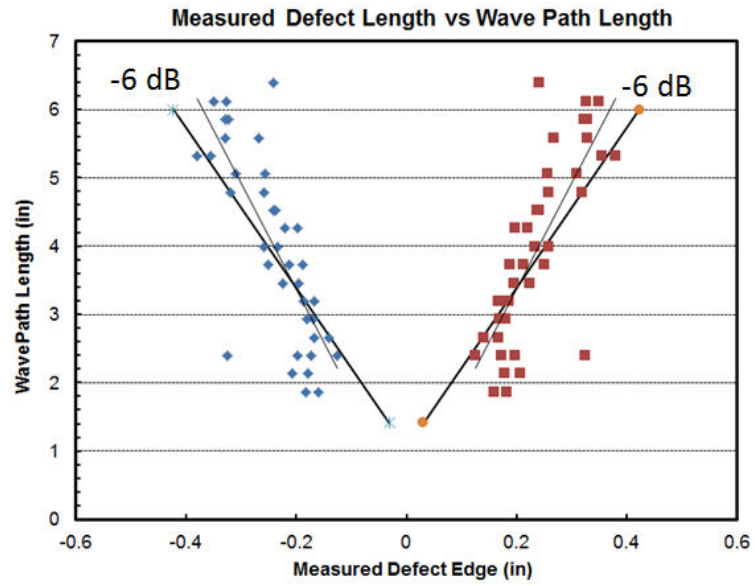
Figure 4-3: Beam spread test results of 1/16" diameter hole in LA1 plate

During this test, the transducer was placed on the steel specimen's surface at various surface distances away from the defect. Due to the near field interference calculated at 1.4 inches, the defect was initially inspected at a wave path length of 1.86" or a surface distance of 1.75" away. The wave path lengths are identified in Figure 4-3, Figure 4-4 and Figure 4-5. This process was repeated while moving the transducer away from the defect by 0.25" increments until a 6" surface distance was attained. Figure 4-3 to Figure 4-5 show two data point groups that represent the left and right measured edges of each length measurement. The thin slanted lines are trend lines representing the slope of each group of data points, and the thick slanted lines represent the calculated beam spread angle of the transducer.

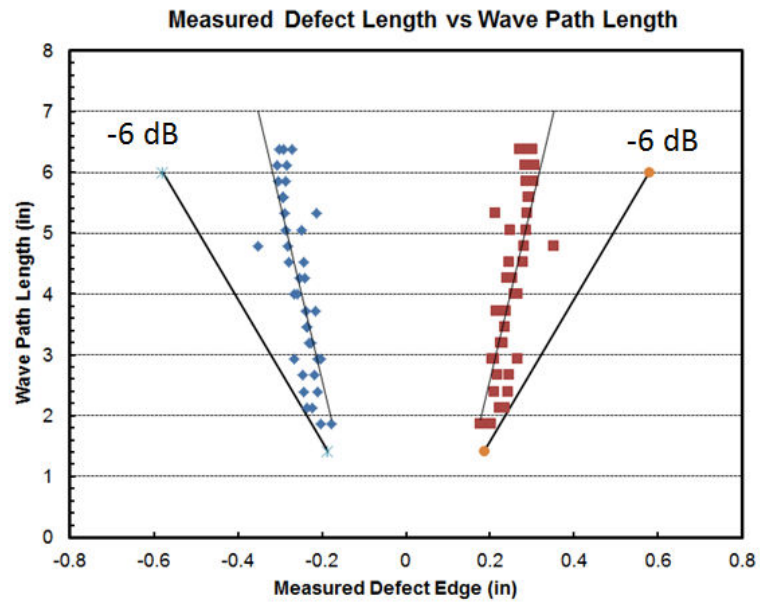
Figure 4-4: Beam spread test results of 3/8" slot in LA1 plate

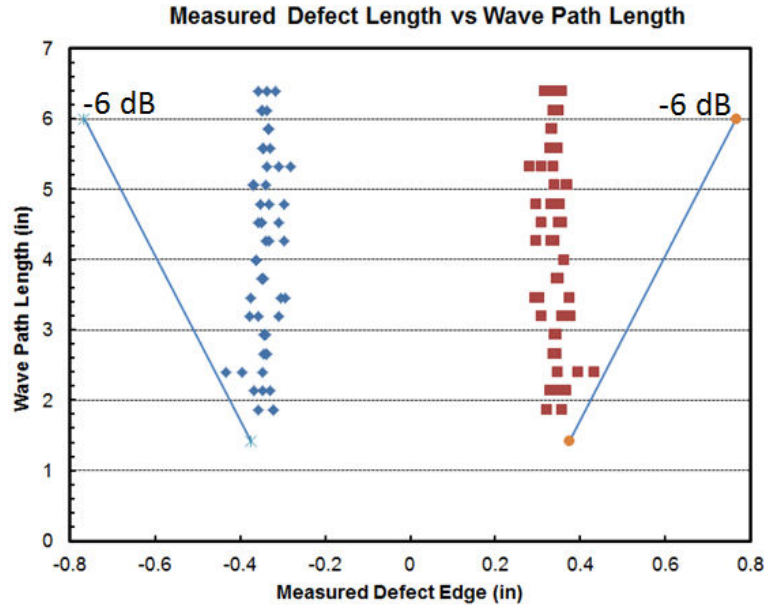
Figure 4-5: Beam spread test results of 3/4" slot in LA1 plate

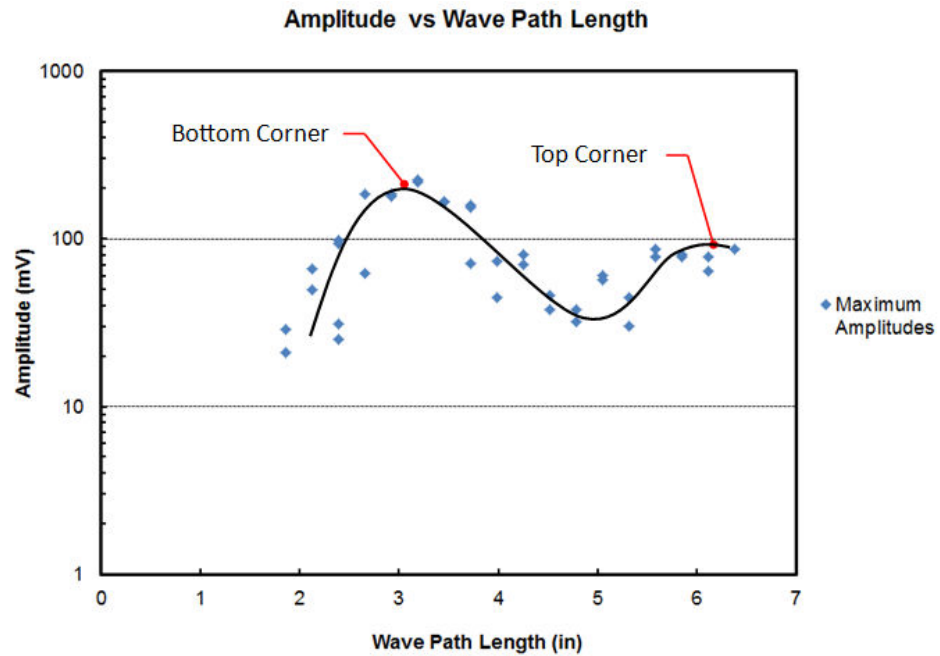
Figure 4-6: Attenuation of the 1/16" hole

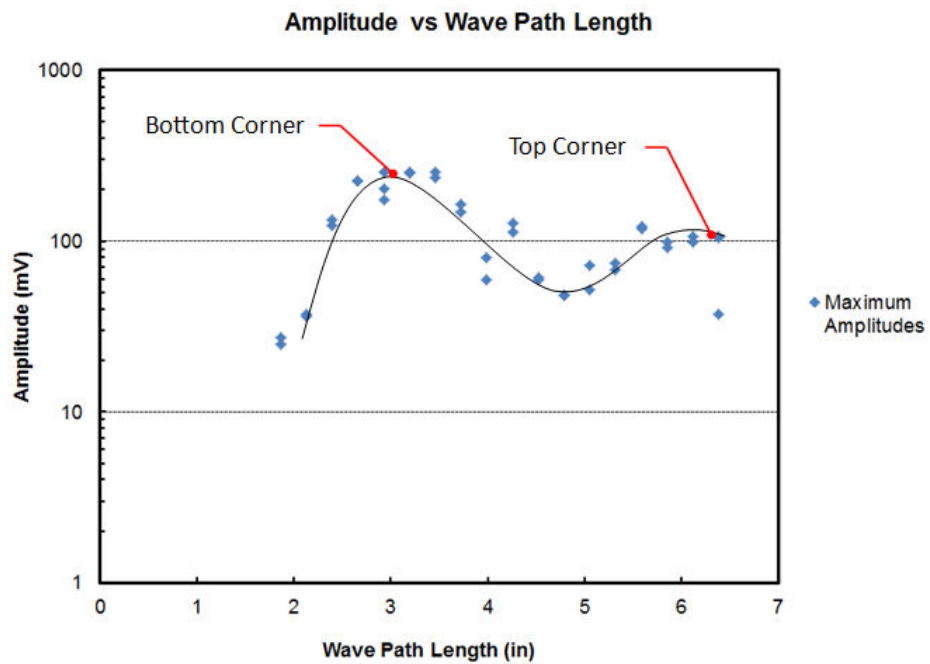
Figure 4-7: Attenuation of the 3/8" slot

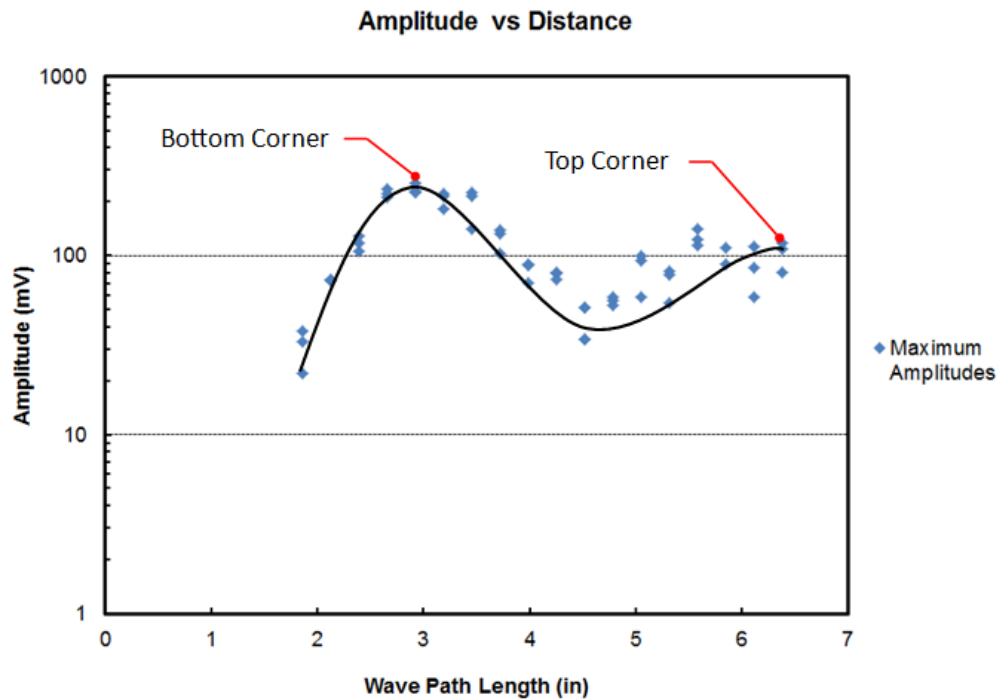
Figure 4-8: Attenuation of 3/4" slot

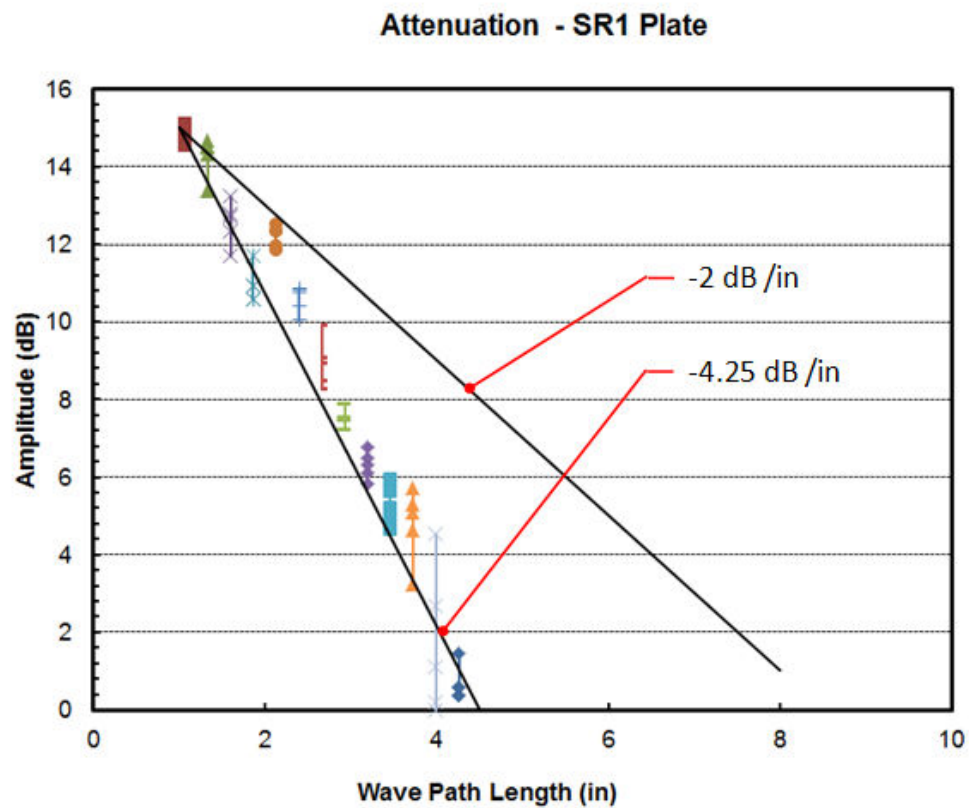
Figure 4-9: SR1, Side 7 attenuation results

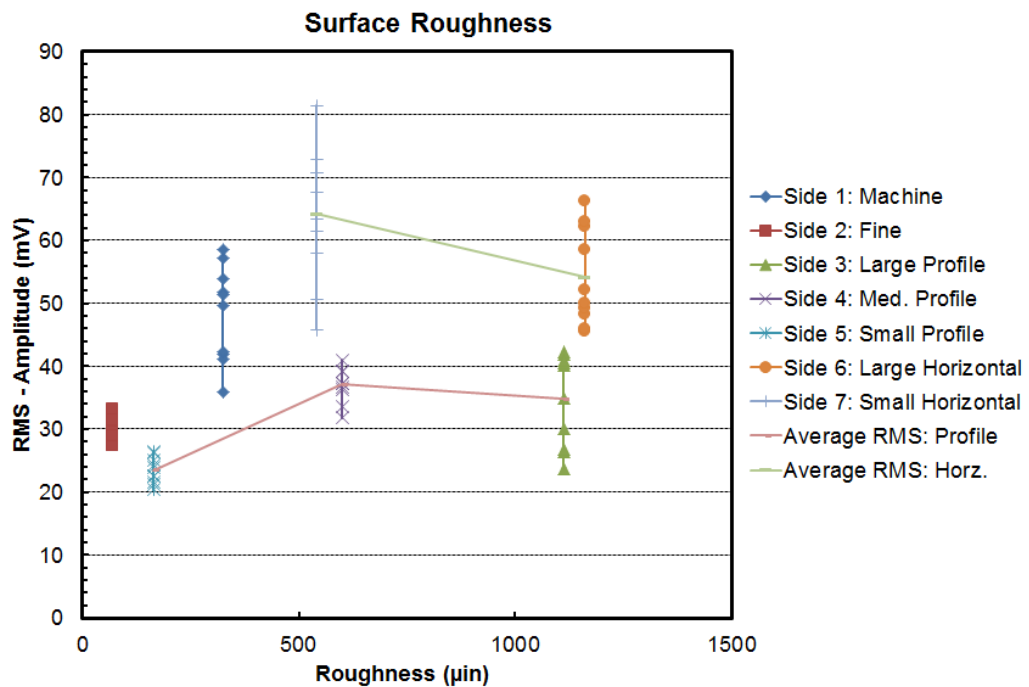
Figure 4-10: RMS values for each surface roughness B-Scan

Figure 4-10 and Figure 4-11 show the maximum reflected amplitude from each inspection vs the measured roughness. The data shown in Figure 4-10 indicates that the reflected amplitude was affected by the texture pattern as well as the texture roughness.

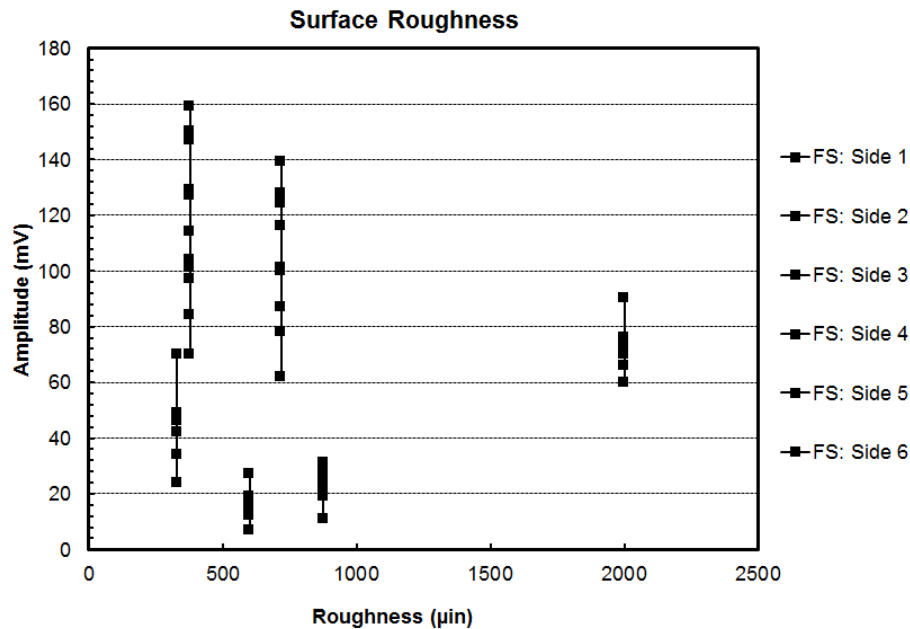
Figure 4-11: Maximum reflected amplitudes for each fatigue specimen side

small amounts of the acoustic wave. As the roughness increased, the interference of the reflected wave also increased. Once the roughness increased to half wavelength, the reflected amplitude decreased.

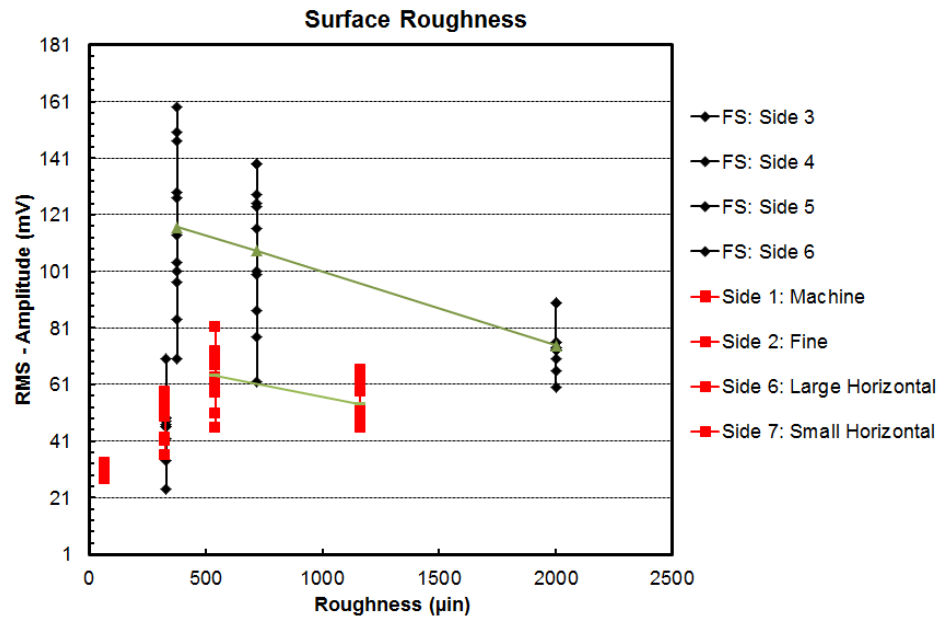
Figure 4-12: SR1 horizontal patterns results vs fatigued specimen results

textures and the fatigued specimens. The averages of both horizontal texture and fatigue crack walls increase in reflected amplitude as the roughness interferes with the reflected amplitude and decreases as the roughness interferes with the wave path reflection.

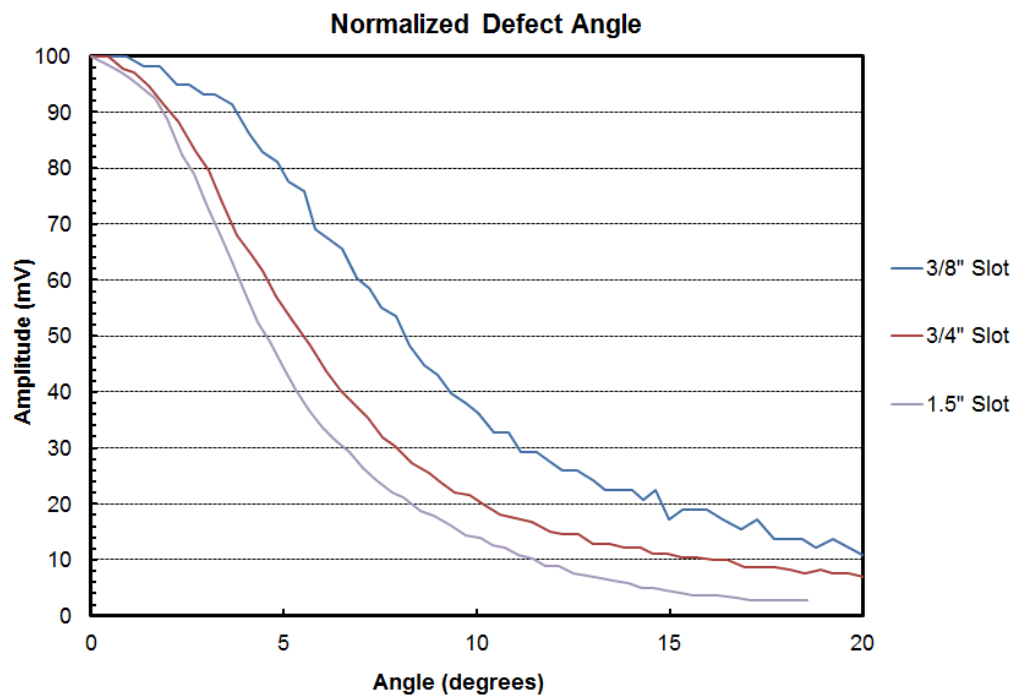
Figure 4-13: Normalized defect angle test B-Scans

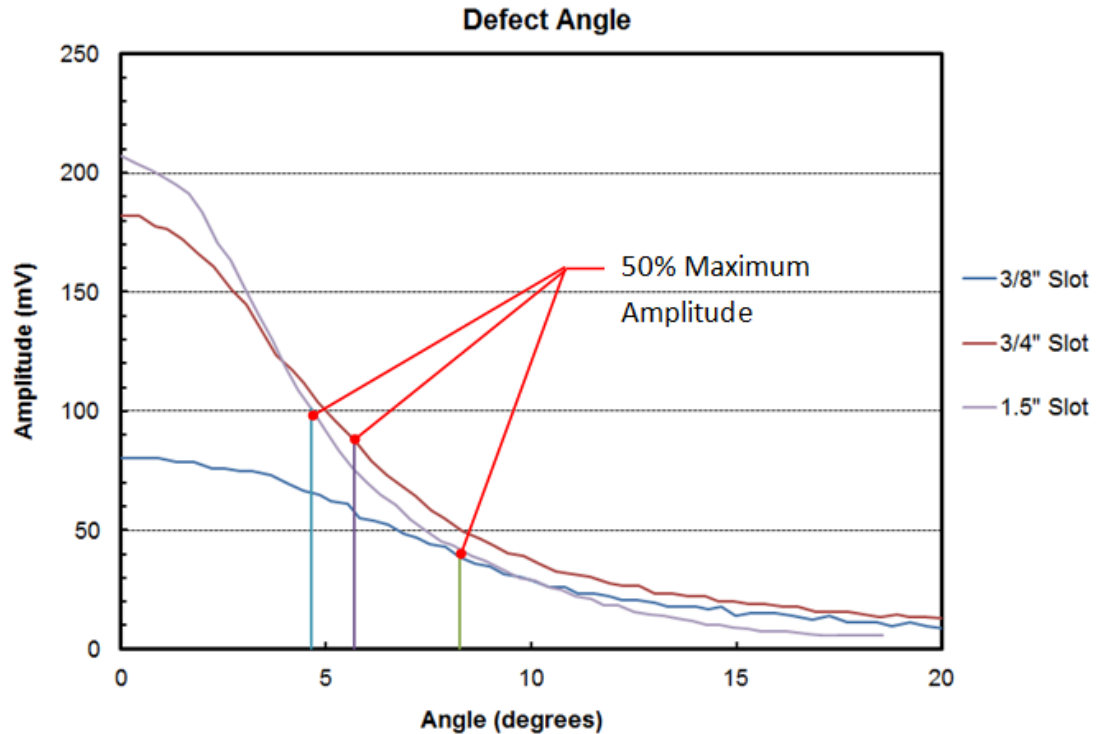
Figure 4-14: Reflected amplitude as the transducer is rotated about the defect

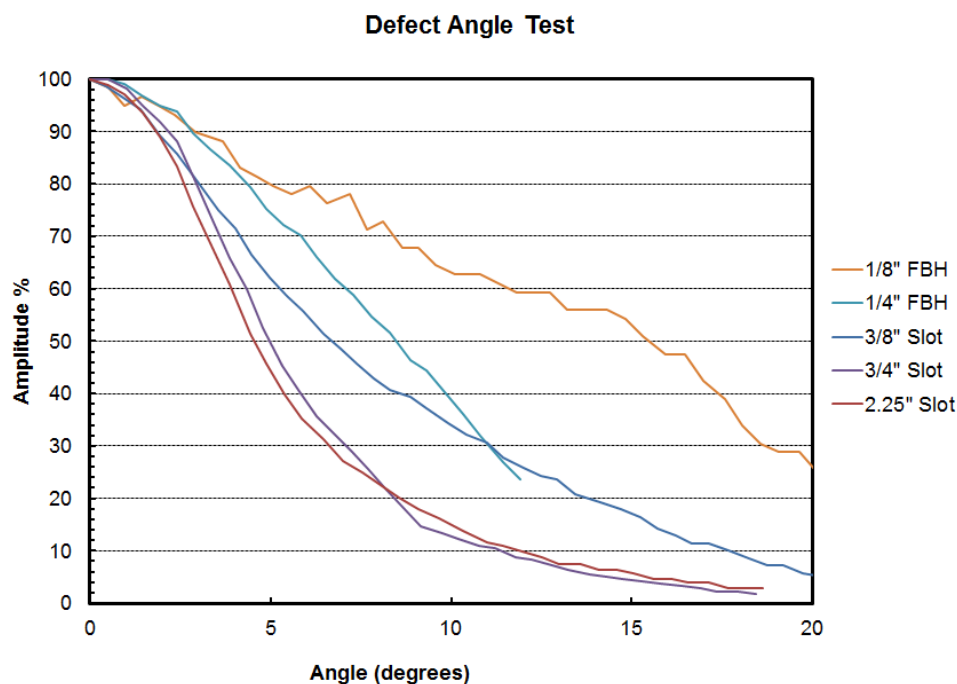
Figure 4-15: Normalized B-Scans relative to transducer rotation

In each of these inspections, the angle beam transducer was rotated while maintaining its location on the steel plate. An encoder was attached to the probe and was used to track the transducer's rotation. Each test yielded a B-Scan relating the reflected amplitude to the transducer angle. Figure 4-15 shows the normalized B-Scans of each inspection relative to the calculated transducer angle.

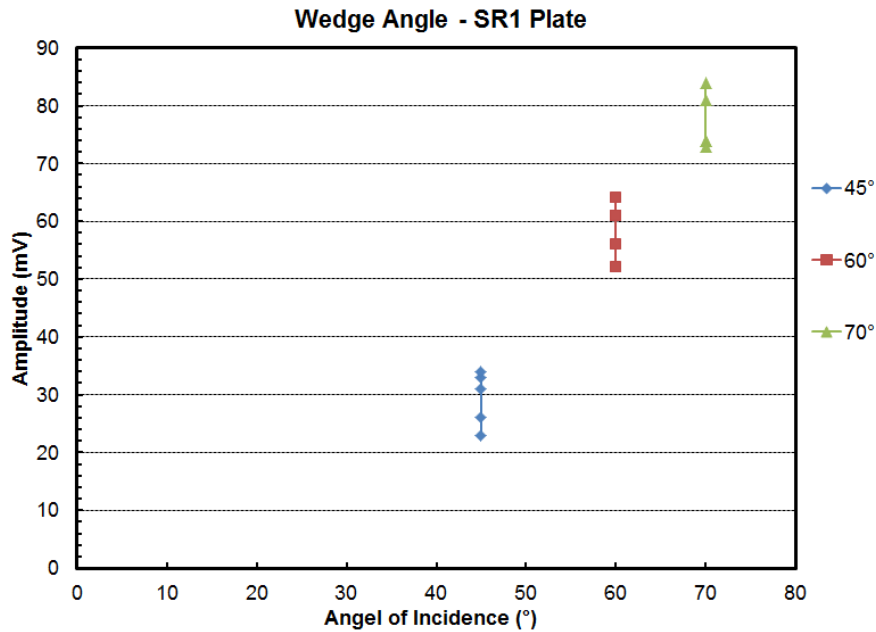
Figure 4-16: Maximum amplitudes from the SR1, Side 7 using the 45°, 60° and 70° wedges

this test indicate that 8.4 dB and 2.4 dB are required to adjust the 45° and 60° probe indications, respectively.

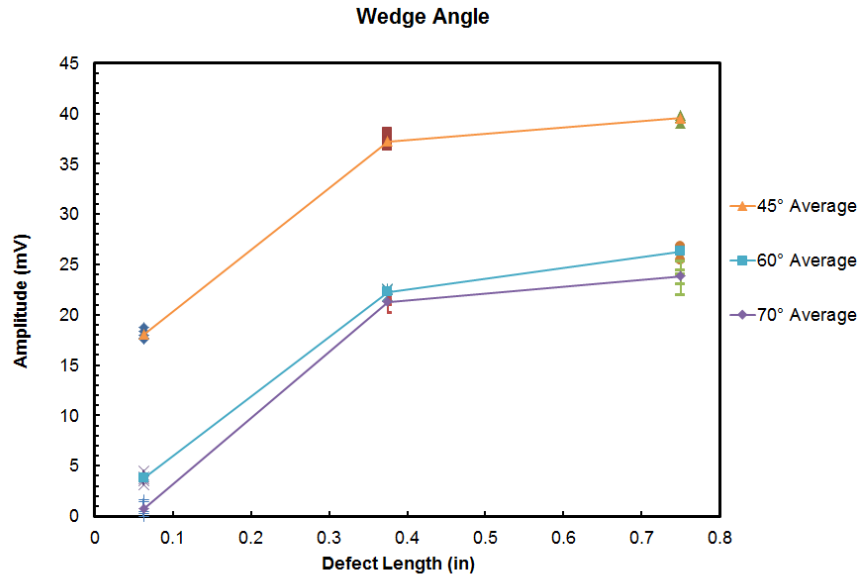
Figure 4-17 Wedge angle results relative to the smallest reflected amplitude

The second procedure inspected the bottom corners of the 1/16" diameter hole, the 3/8" slot and the 3/4" slot in the LA1 test specimen using each of the three angle beam probes. While the AWS assumes all cracks are vertically oriented, this is not always the case. The bottom corners were chosen to demonstrate the effect that the defect orientation has on all three transducer wedge results.
