EVALUATING THE VARIABLES THAT IMPACT ULTRASONIC TESTING

A thesis presented to the Faculty of the Graduate School at the University
of Missouri – Columbia

JULY 2014

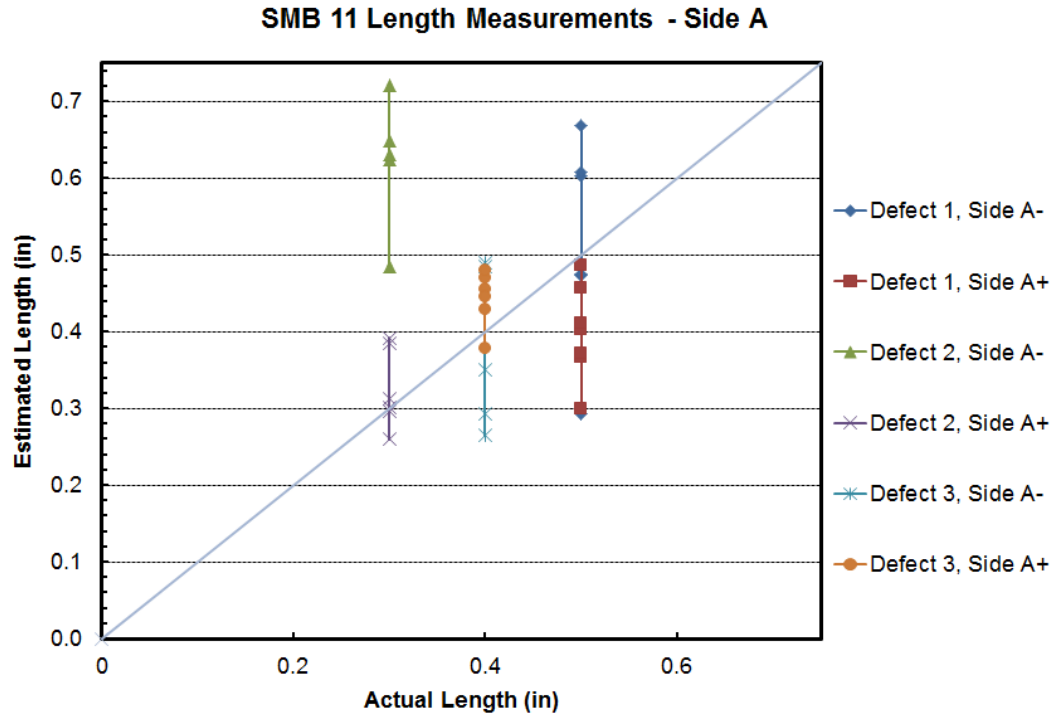
Figure 4-18: SMB 11 Length measurements from Face A+ and Face A-

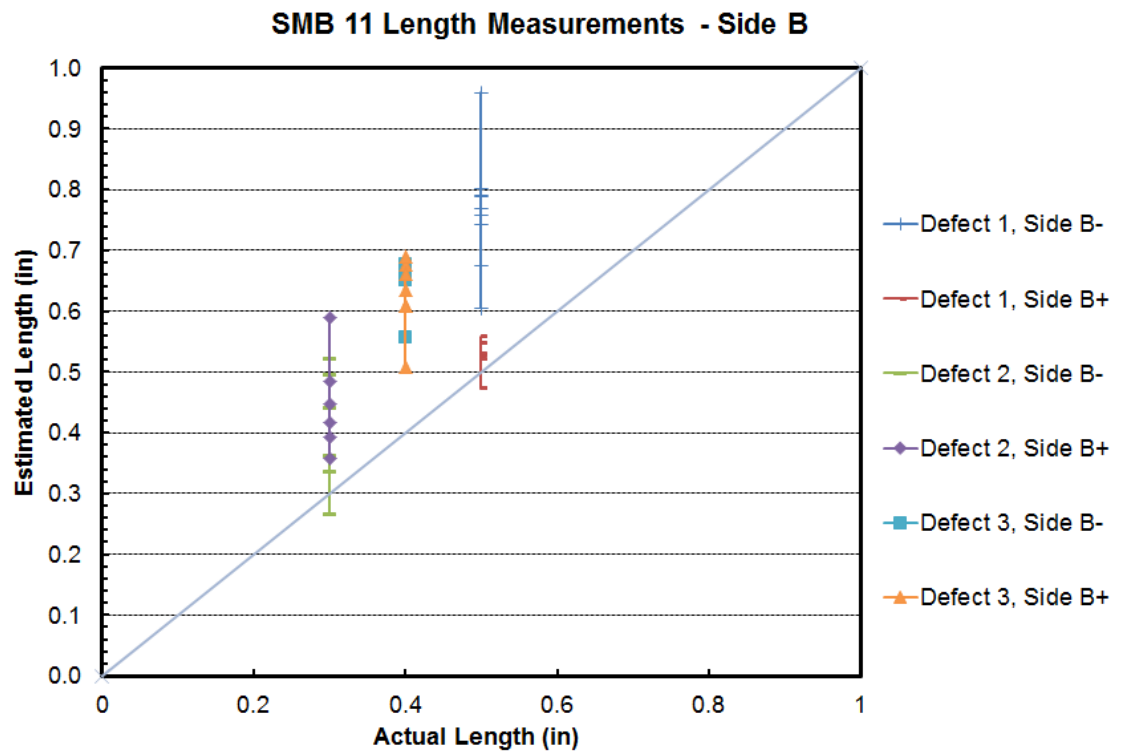
Figure 4-19: SMB 11 Length measurements from Face B+ and Face B-

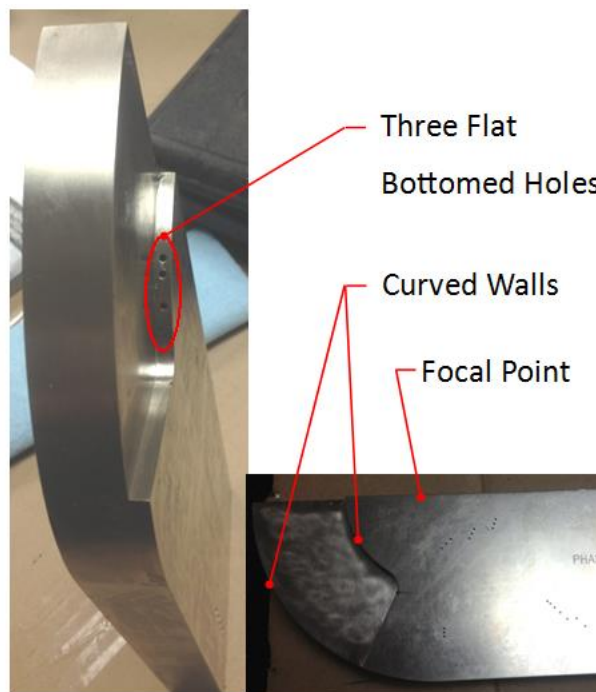
Figure 4-20: Phased Array IIW Block

The phased array IIW block shown in Figure 4-20 was inspected using a Phasor XS, PAUT pulser receiver. The phased array IIW block contains two curved walls of different radices whose focal point is identified in Figure 4-20. Three flat bottom holes are located on the interior curved wall. These flat bottom holes are difficult to identify using a standard UT A-Scan; however, the PAUT S-Scan clearly identifies the three circular holes as seen in Figure 4-22.

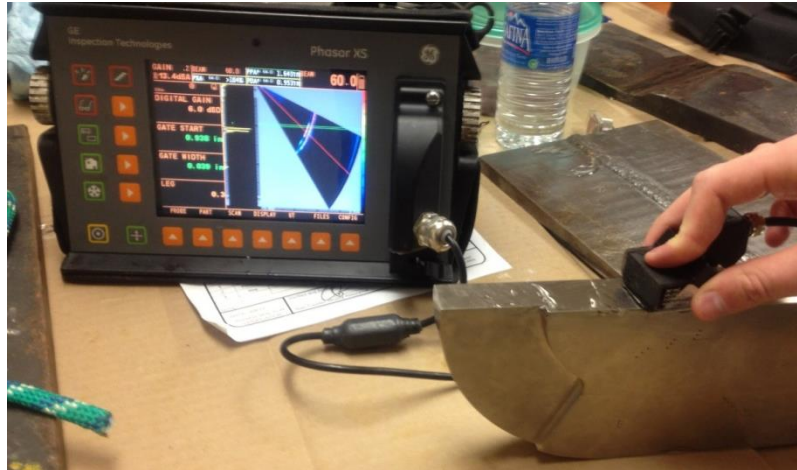
Figure 4-21: PAUT inspection of the phased array IIW block

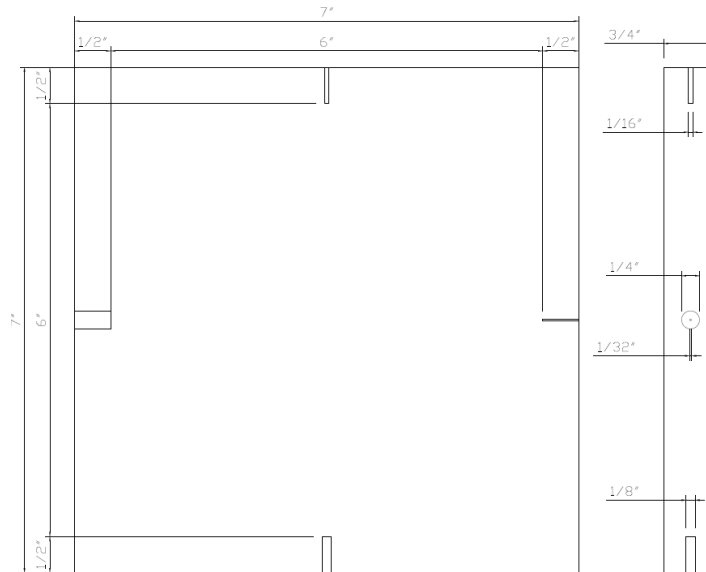
Figure A-1: Flat Bottom hole specimen

The FBH1 is a 7" x 7" x 3/4" square A36, steel plate containing four 1/2" deep holes of varying diameter shown in Figure 3-7. The plate has four side drilled holes drilled of 1/4", 1/8", 1/16", 1/32" diameters drilled 1/2" into the plate. The size of the 1/32" hole was on the limit of detection because it is close to half the wavelength of a 2.25 MHz transducer. The other defects have diameters 2, 4 and 8 times the size of the 1/32" hole. Schematics of the FBH1 plate shown in Figure 3-7 are located in Figure A-1.

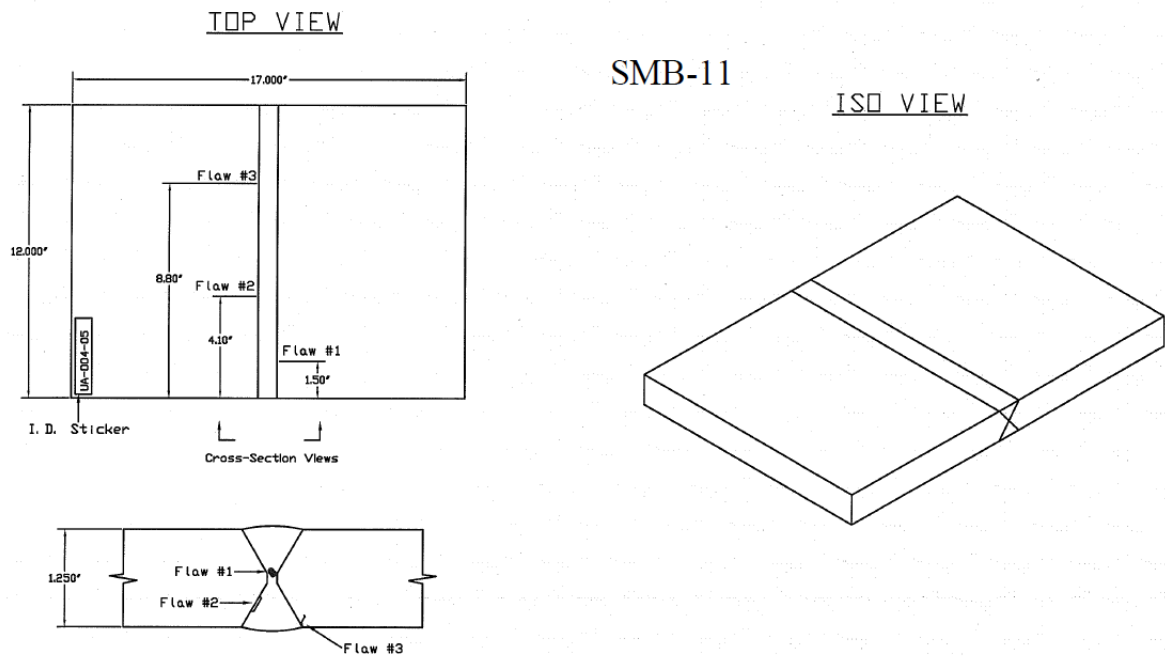
Figure A-2: Details depicting the SMB 11 plate defect locations

welded plate, as seen in Figure 3-9 has three fabricated cracks implanted into the volume of the weld. These implanted defects provided a realistic sample of cracks in steel welds. Schematics of the SMB-11 plate shown in Figure 3-9 are located in Figure A-2.

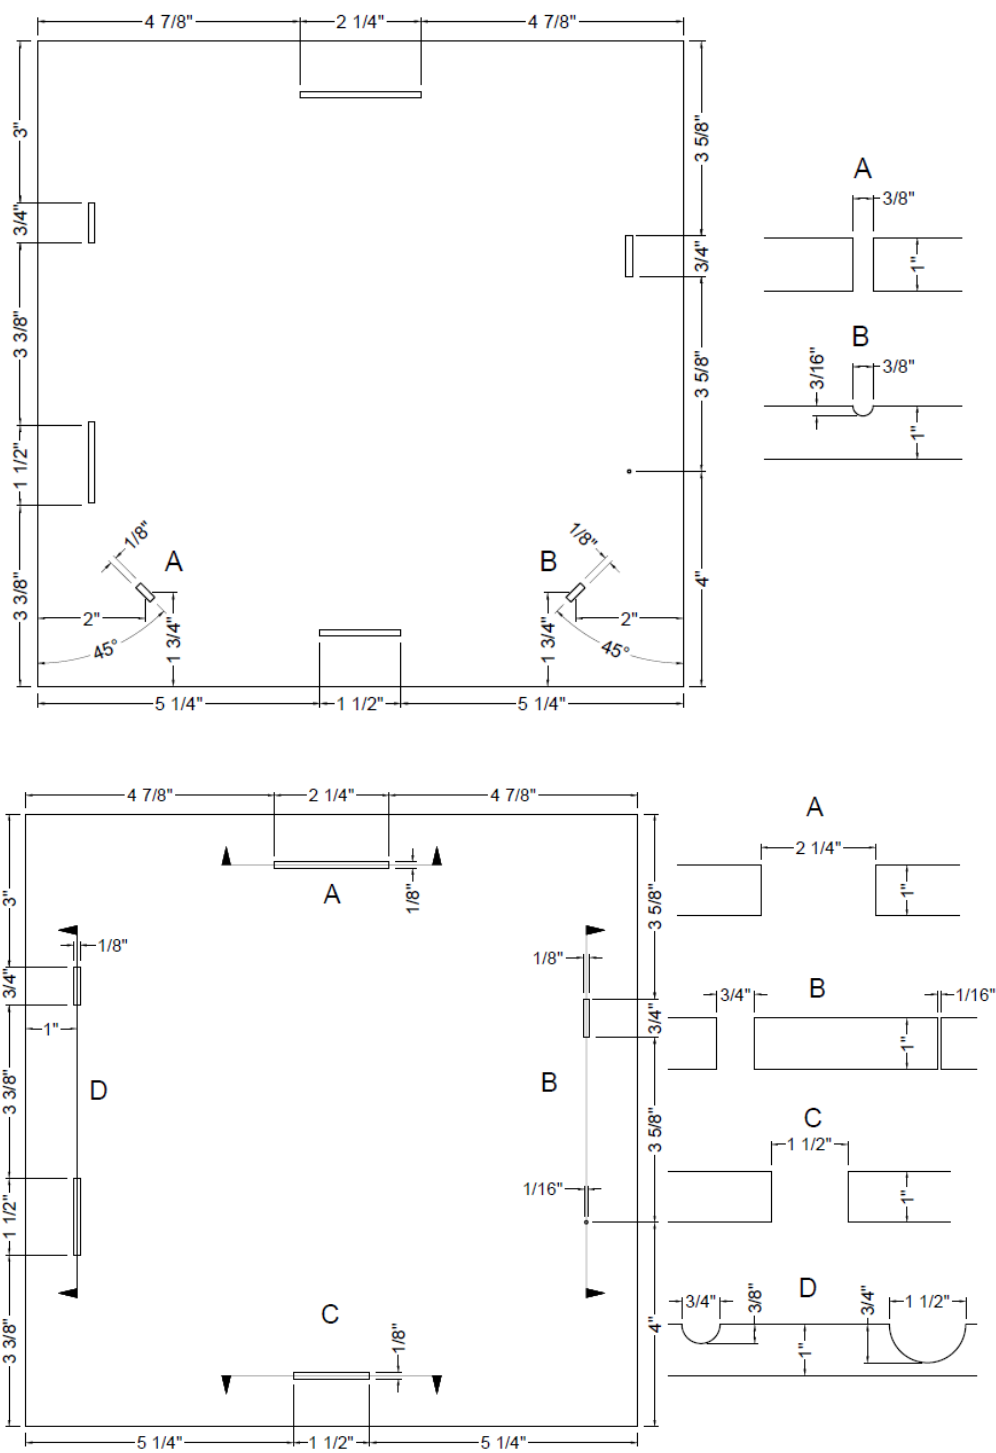
Figure A-3: Length-amplitude specimen design drawing

The LA1 specimen is made of A36 steel, 1" thick 12"x12" with electric discharge machined (EDM) cuts. There are eight cuts of varying lengths, as seen in Figure 3-8. Four rectangular slots were cut through the steel at different lengths. Three fingernail-like grooves were made in the steel to resemble fatigue cracks. One 1/16" diameter hole, similar to the 1/16" diameter hole used for calibration, was cut into the plate. The defect lengths were designed so that some defect lengths were smaller than the transducer and some defect lengths were larger than the transducer. Schematics of the LA1 plate shown in Figure 3-8 are located in Figure A-3.

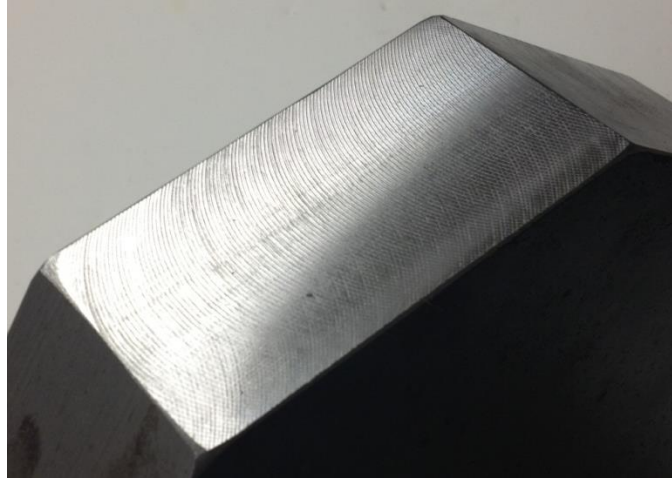
Figure A-4: Surface roughness specimen: small profile finish

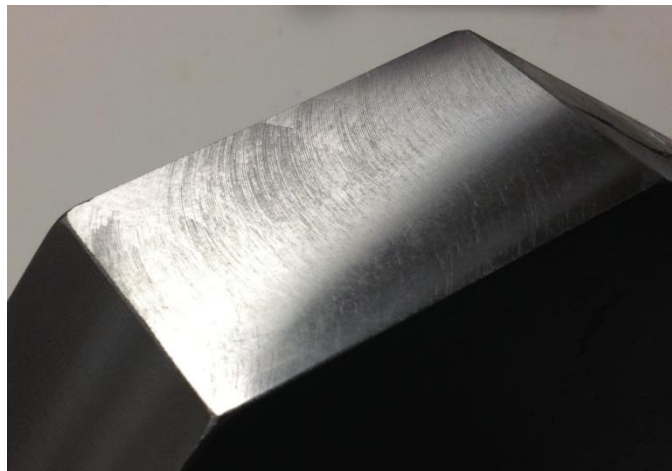
Figure A-5: Surface roughness specimen: fine finish

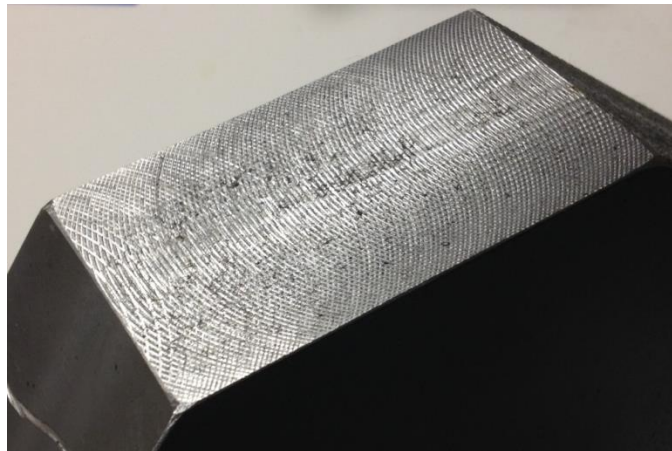
Figure A-6: Surface roughness specimen: medium profile finish

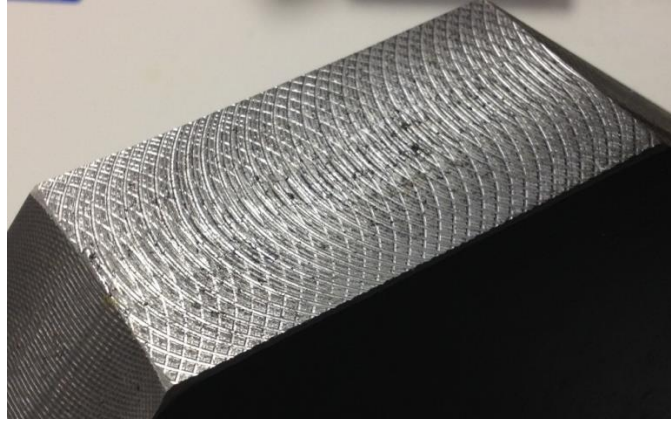
Figure A-7: Surface roughness specimen: large profile finish

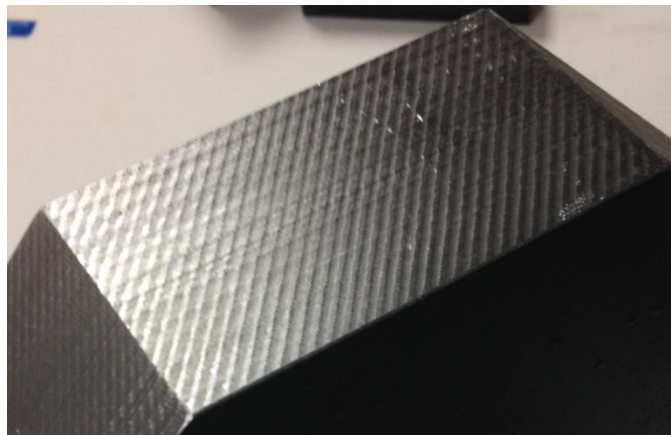
Figure A-8: Surface roughness specimen: small horizontal finish

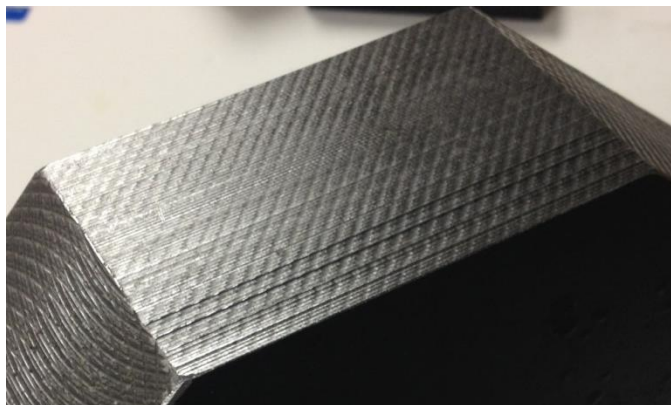
Figure A-9: Surface roughness specimen: large horizontal finish

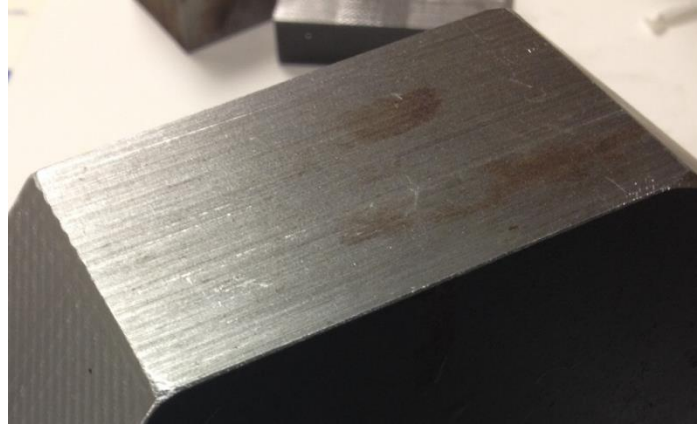
Figure A-10: Surface roughness specimen: manufacture cut finish

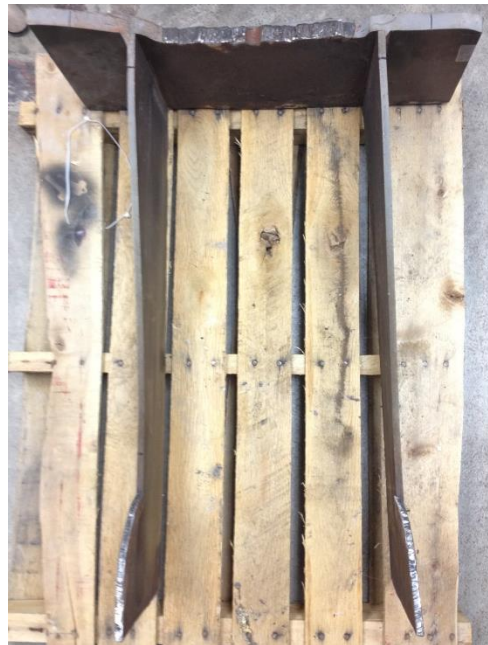
Figure A-11: SR Fatigue Specimen 1

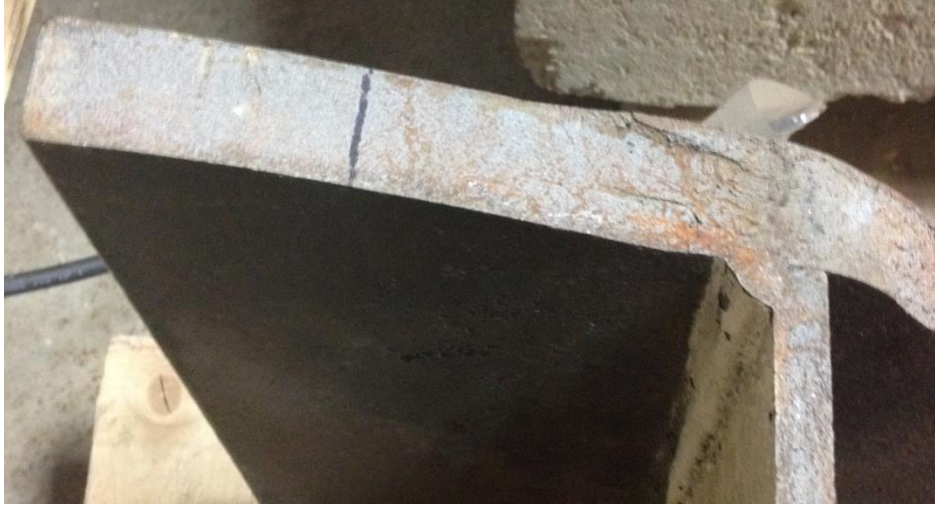
Figure A-12: SR-Fatigue Specimen 1-Side 1

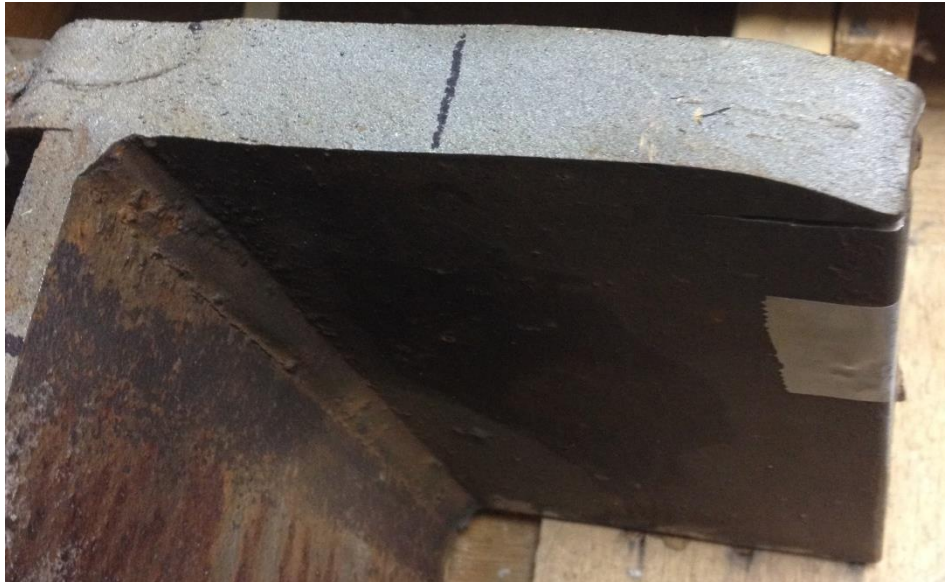
Figure A-13: SR-Fatigue Specimen 1-Side 2

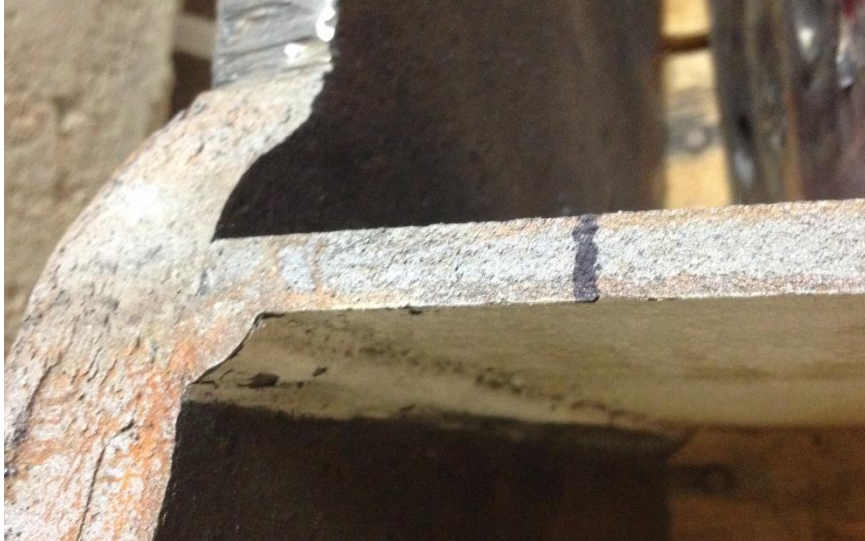
Figure A-14: SR-Fatigue Specimen 1-Side 3

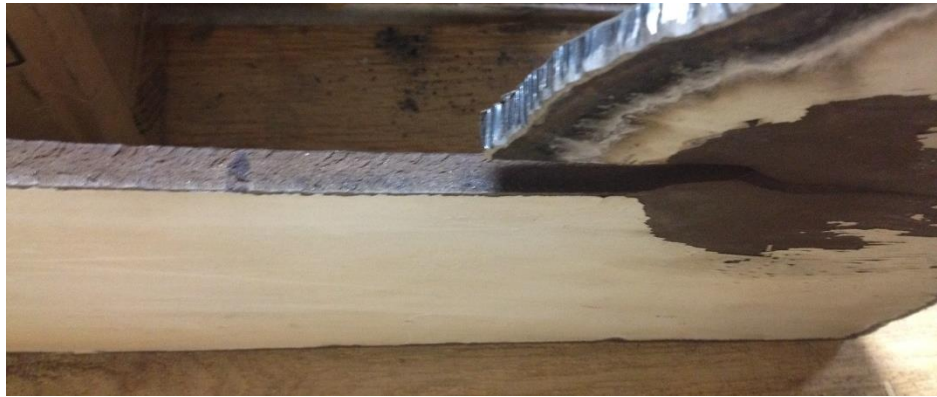
Figure A-15: SR-Fatigue Specimen 1-Side 4

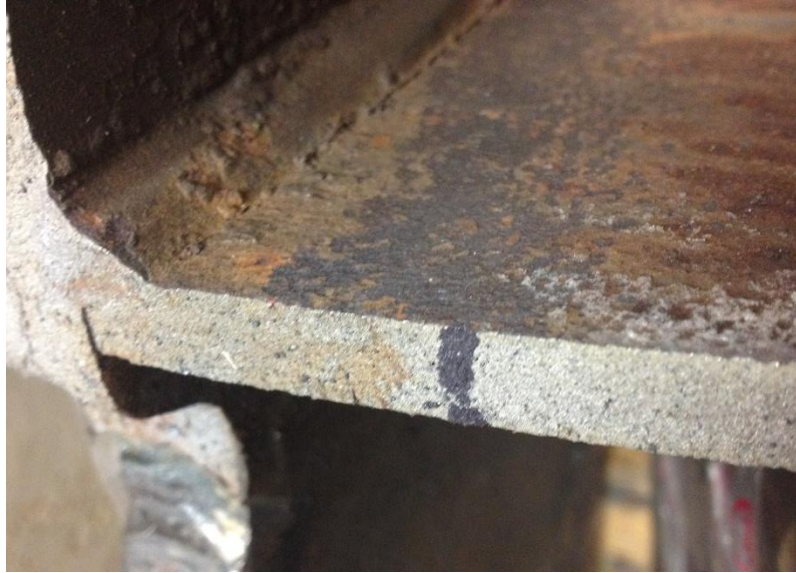
Figure A-16: SR-Fatigue Specimen 1-Side 5

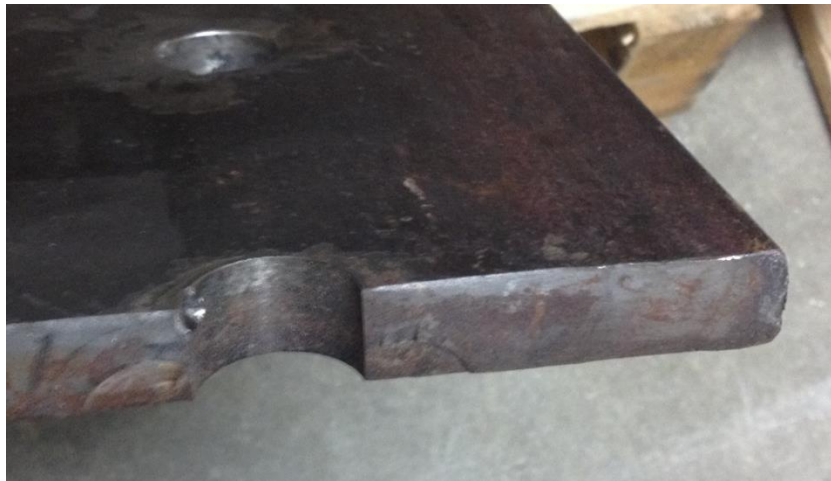
Figure A-17: SR-Fatigue Specimen 2-Side 6

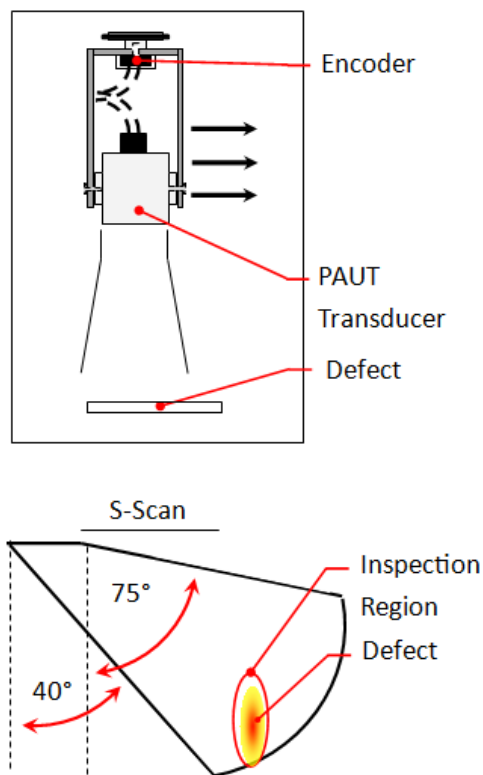
Figure B-1: Diagram of S-Scan inspection region

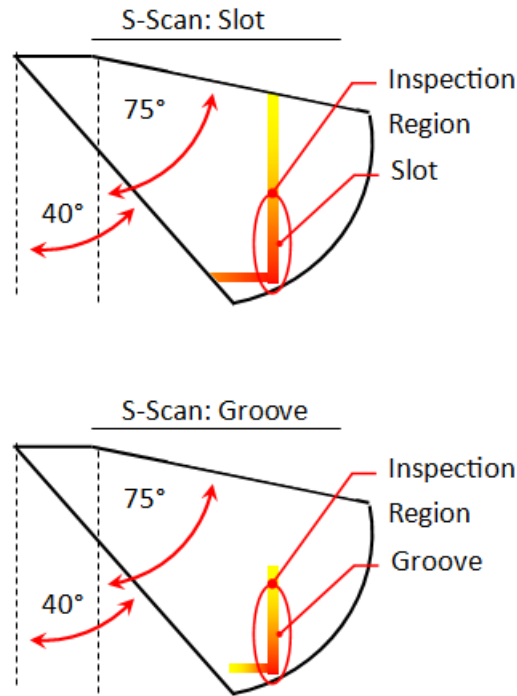
Figure B-2: Predicted S-Scan measurements of LA1 plate slot and groove defects

measured length of each defect is the distance between the measured edges of both defect sides.

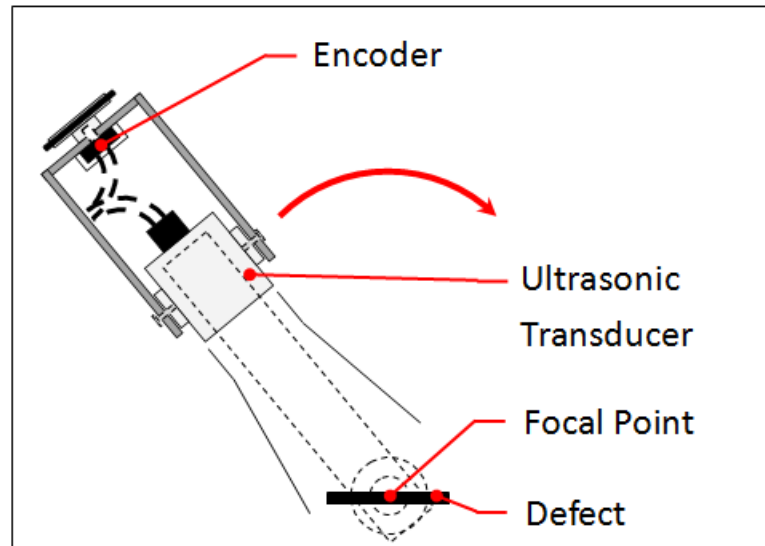
Figure B-3: Defect Angle test setup diagram

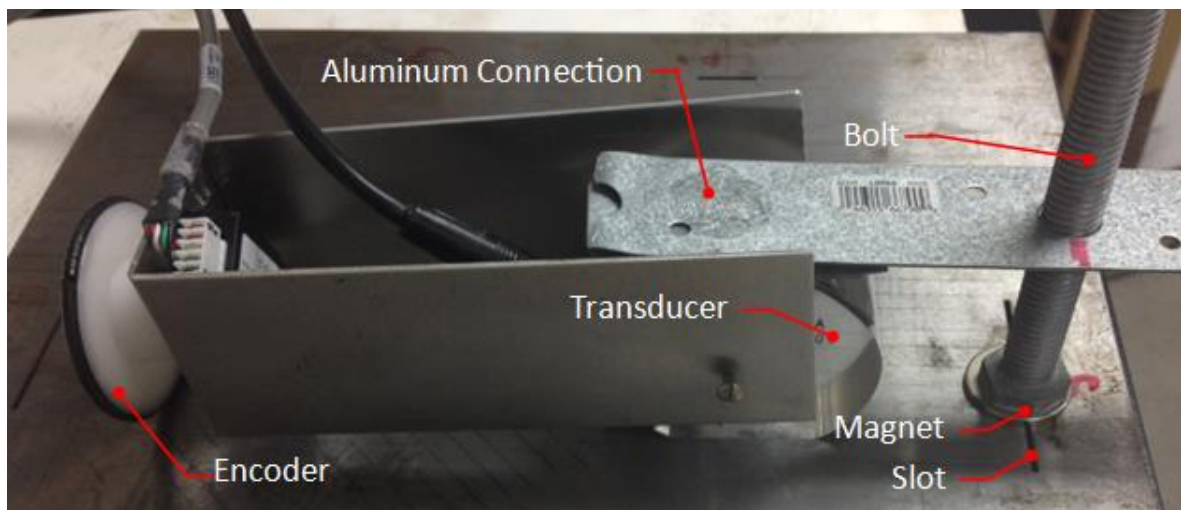
Figure B-4: Defect Angle test setup

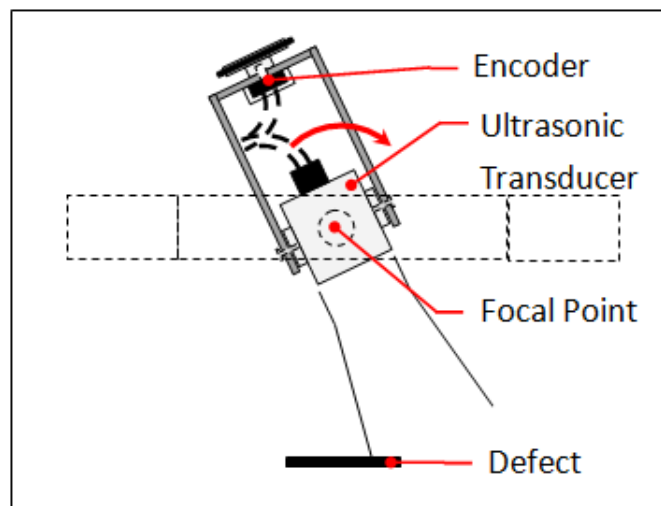
Figure B-5: Transducer rotation test setup diagram

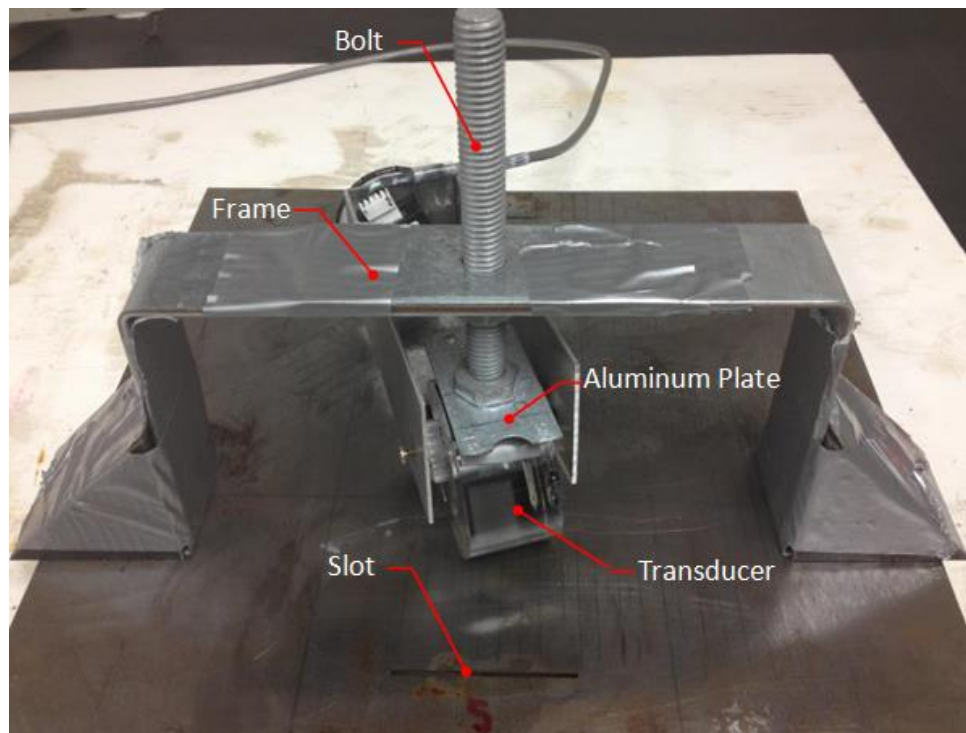
Figure B-6: Transducer rotation test setup
