# Stress Corrosion Cracking Issues in Syngas Plants that may be Missed by Risk-Based Assessment\*

\*Published by the AIChE Annual Safety in Ammonia Plants and Related Facilities Conference 2014

**D. M. Firth, Metallurgist and C. W. Thomas, Metallurgist**  
Quest Integrity Group New Zealand

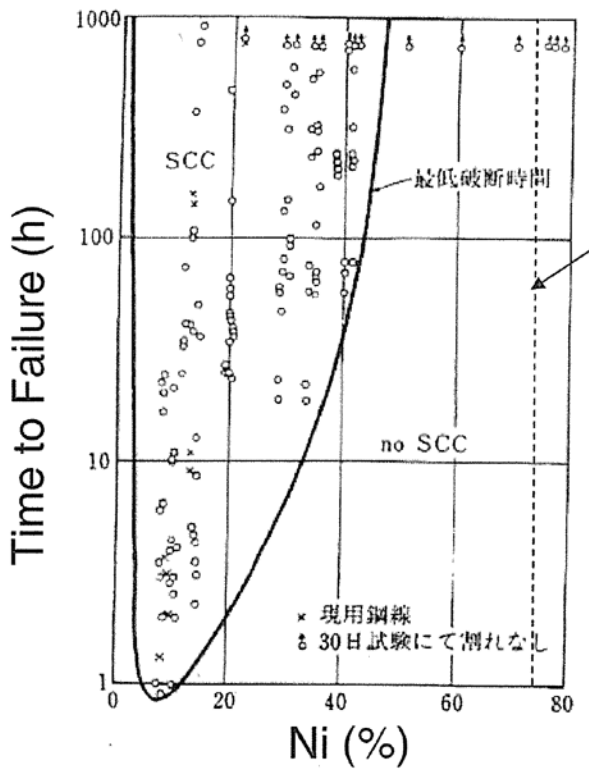
Figure 11. Time to failure due to SCC in boiling 42% MgCl<sub>2</sub>. Inconel 600 has about 77%Ni

- Chloride SCC as the nickel content is well above the critical level see Figure 11 and the level of chloride in the boiler water was minimal ( $\ll 1$ ppm).
- Caustic cracking as the concentration required would be excessively high, see Figure 12. Caustic was not used in the process and the boiler water was operated consistently at pH 9-9.5.
- Other boiler chemicals such as volatiles and phosphates causing SCC issues.
- Mechanical load.
- Fabrication.
- Hydrogen embrittlement from the gas. However, hydrogen is likely to be associated with the cracking process and to be formed due to surface corrosion.

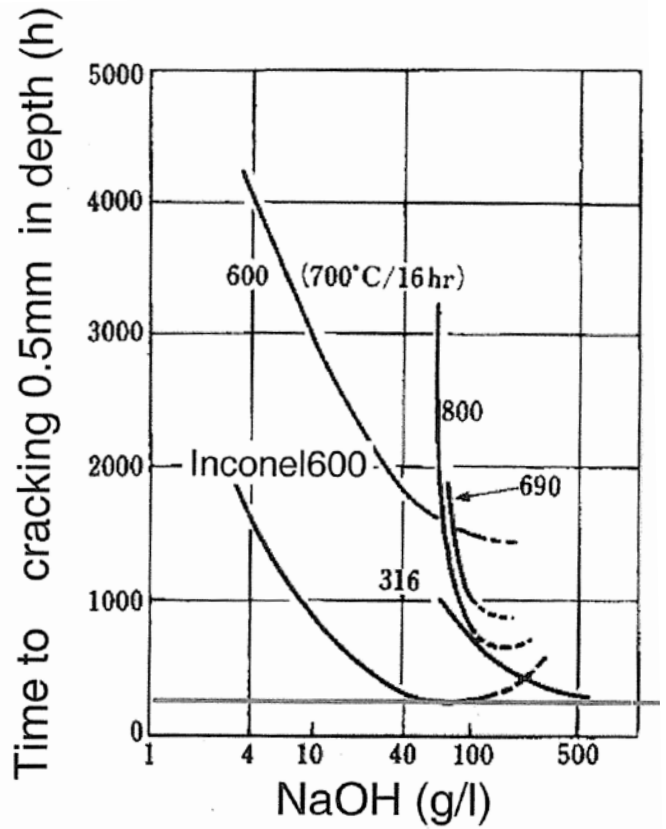
Figure 12. Time to crack Inconel 600 in NaOH solution

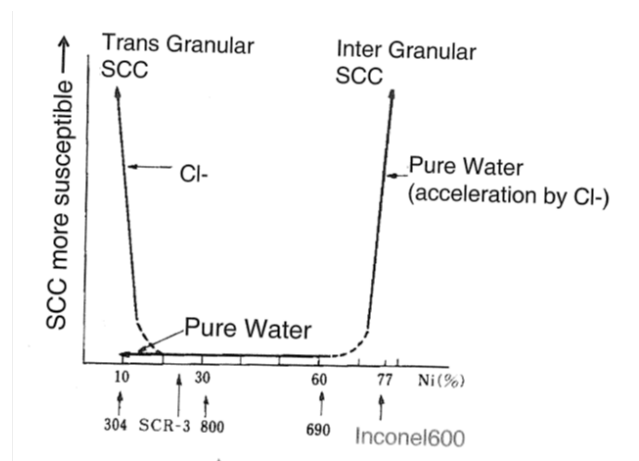
Figure 13. Risk of PWSCC for varying nickel content.

PWSCC in Inconel 600 with Alloy 182 welds is a common problem in the nuclear power industry. Cases have occurred since 1986 and have resulted in extensive research programs [6,7]. PWSCC tends to be intergranular in wrought alloys and follows the interdendritic of welds. However, the exact mechanism has not been defined [7] but it is known to be dependent on the nickel content, see Figure 13. As a result of the extensive problems Inconel 690 (27-32% Cr, 7-11% Fe, 58% Ni) with Inconel 152 weld material has become the standard to prevent PWSCC in the Nuclear Industry as this alloy has a lower nickel content than the critical level for PWSCC, see Figure 13. Note Inconel 600 has about 72% nickel. However, it is to be noted that Inconel 152 is not as weldable as Inconel 182.
